**AVIATION INVESTIGATION REPORT
A12P0008**

ENGINE POWER LOSS AND HARD LANDING

**ROYAL CANADIAN MOUNTED POLICE
EUROCOPTER AS 350 B3 (HELICOPTER), C-FMPG
CULTUS LAKE, BRITISH COLUMBIA, 1.5 NM E
17 JANUARY 2012**

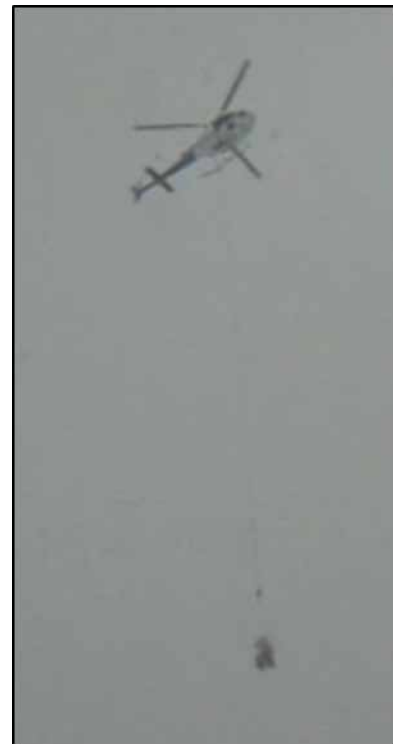
Photo 1. Human external transportation system (HETS) training flight (Source: RCMP)

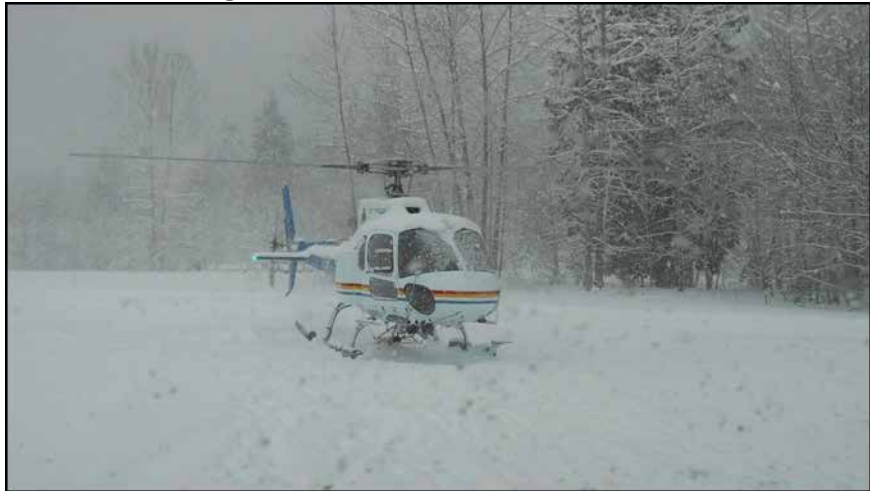
After the helicopter was reconfigured for the flight to CYVR, the pilot entered the cockpit and prepared for start-up. At the same time, 2 ground crew members removed the snow accumulation from the 2 front windscreens. At 1349, the pilot started the helicopter, and the snow was flung off the blades. A significant amount of snow remained on the upper surfaces of the fuselage and tail boom (Photo 2).

Photo 2. C-FMPG, moments before final take-off (Source: RCMP)

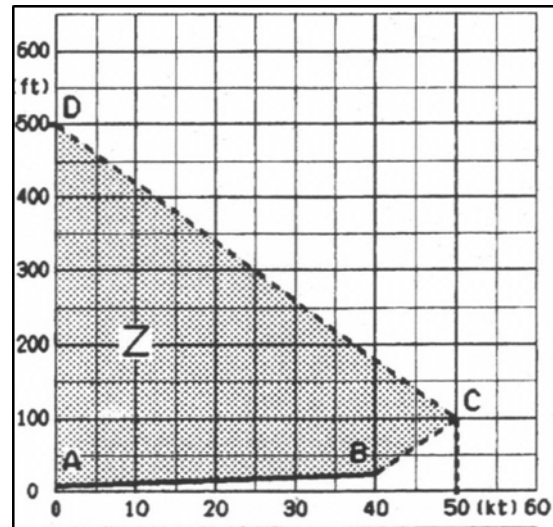
The AHE describes the area within which there may not be enough energy available for the pilot to be able to perform a safe landing after an engine failure. The AHE shows the low hover point at 8 feet, and the high hover boundary is variable (325 feet to 650 feet) depending on altitude and aircraft weight.

The shaded area of the AHE (Figure 3 and Appendix B) identifies airspeed and altitude-avoid combinations (Z). If the helicopter is being operated within that area, pilots should not expect to establish full autorotation and carry out a successful landing.

Figure 3. Simplified airspeed-height envelope (AHE) chart (image: Eurocopter, *Flight Manual AS 350 B3 (97-40)*, page 3)

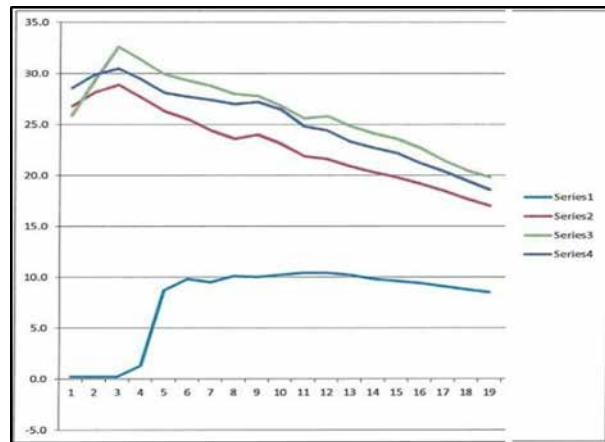
Figure 4. Temperature in plenum and filter

During the trial, it was noted that, in the cold outside air, the inlet grill and sand filter unit at the top of the engine cowling did not cool down after engine shutdown. Instead, following engine shutdown, the temperatures increased quickly from 0.2°C at shutdown to 10°C, dropping only to 8.5°C at the 90-minute mark. Similarly, the temperatures inside the plenum itself, after peaking to about 33°C, fell to no lower than 17°C during the test. Figure 4 shows the temperature drop in °C over 19 increments of 5 minutes. During testing, an opening appeared in the snow layer on the top of the engine cowling and engine intake grill. This opening was created by rising hot air from the engine, which passed up the plenum and out of the intake, causing a small area of melting in the layer of snow that had formed.

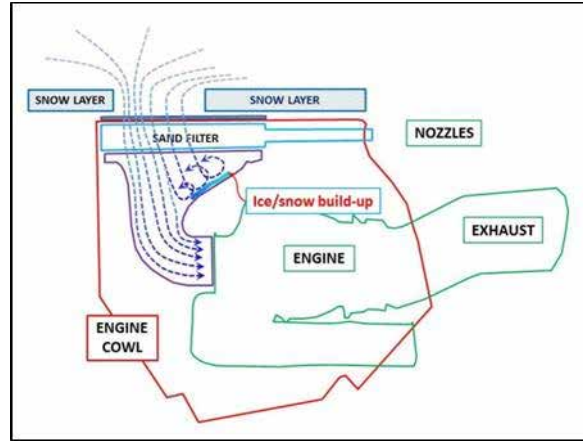
In testing, residual heat following an engine shutdown was enough to cause a narrow opening to appear at the forward edge of a snow-covered intake grill (Figure 5). The high airflow through the air inlet would then have begun to progressively erode the snow layer rearwards, increasing the aperture size and causing the airflow to gradually change (Figure 6). As the size of the opening on the grill increased, the airflow pattern would have likely started to form recirculating eddy currents on the rear face of the plenum, increasing in intensity as the opening grew. The intake air contained moisture—from both the atmosphere and the melting snow layer on top of the grill—and probably became colder due to pressure reduction in the plenum resulting in slush gathering on the rear face of the plenum (Figure 6). This soft ice buildup phenomenon is not unheard of—it is the very contamination development seen in the French certification tests described previously in this report. The only significant contributing factor not present in the test regimes, however, was the increasing surface area of the air intake as a result of the snow layer eroding gradually in the airflow stream. At some stage in this process, the airflow pattern likely changed to impinge on the accumulation deposited on the rear face of the plenum, and perhaps in combination with vibration, caused the deposit to separate from the plenum surface and be sucked into the engine inlet (Figure 7 and Figure 8).

Figure 6. Airflow snow buildup

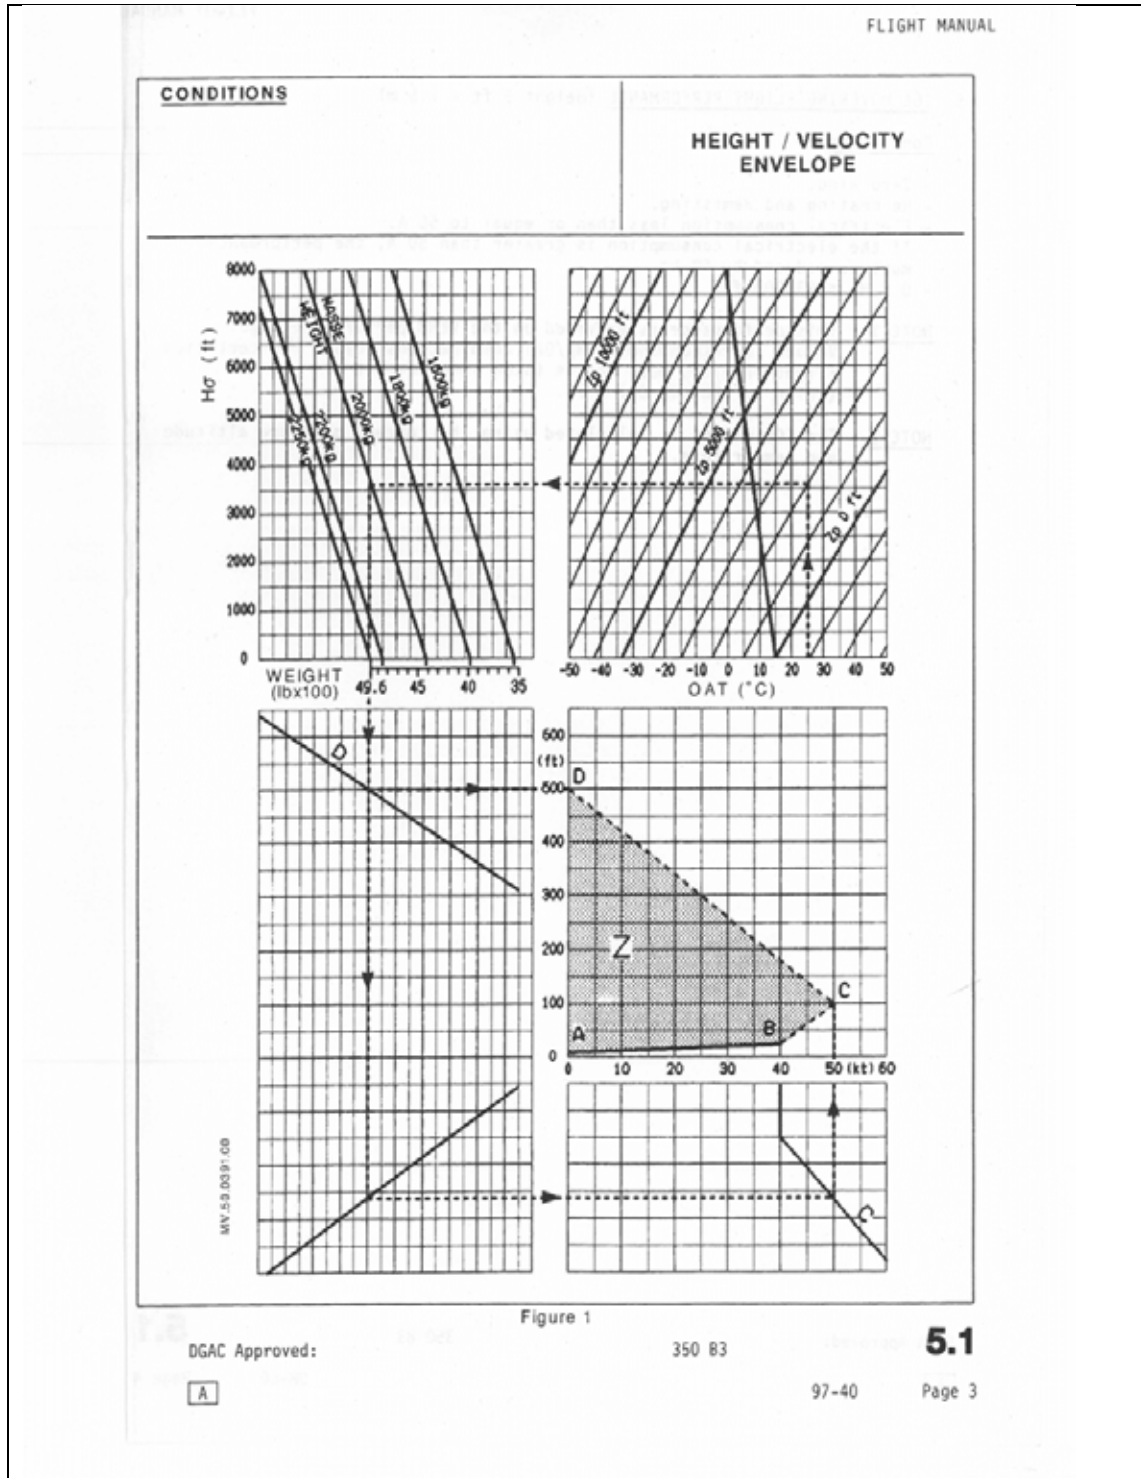
Appendix B – AS 350 rotorcraft flight manual charts for airspeed-height envelope²⁵
