**AVIATION INVESTIGATION REPORT  
A13H0002**

**COLLISION WITH WATER**

**GOVERNMENT OF CANADA, DEPARTMENT OF TRANSPORT  
MBB BO 105 S CDN-BS-4 (HELICOPTER) C-GCFU  
M'CLURE STRAIT, NORTHWEST TERRITORIES  
09 SEPTEMBER 2013**

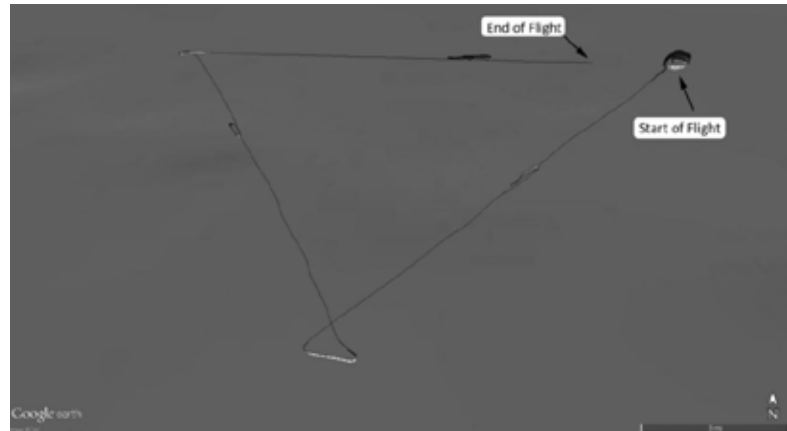
Figure 3. Plot of the entire flight track

At 1805, 27 minutes after CCG364's last broadcast, the helicopter's position was checked on the flight following system's (FFS) control display unit (CDU) located in the wheelhouse. The FFS CDU indicated that the helicopter was at a distance of 3.2 nm, on a bearing of 287° true from the vessel. The last and only displayed position available to the crew in the wheelhouse was on the FFS CDU as N 74° 45.56, W 117° 49.52<sup>13</sup> at 1741. Several<sup>14</sup> attempts to establish contact with CCG364 were then made, to no avail.

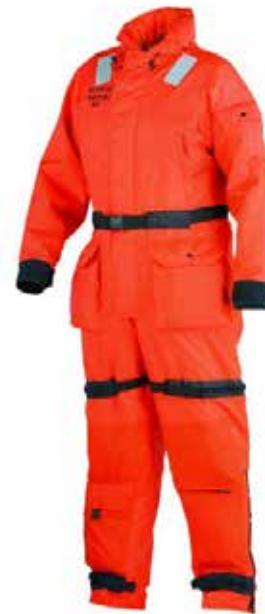
Figure 7. MS2175 TC suit  
(Source: Mustang Survival)

Both the master and the scientist were wearing a Mustang Survival model MS2175 TC helicopter transport suit (Figure 7), which is approved by ASD/CCG for use as an immersion suit. However, this model is not certified to any standard and has an insulation value of 0.4 clo in still water. This suit is based on Mustang Survival's original floater suit concept with modifications to assist the wearer in a safe egress from a ditched helicopter. Compared to the floater suit, the helicopter transport suit has less buoyancy, which allows for safe egress, and has additional anti-exposure protection that affords the wearer increased in-water survival time. Mustang Survival advises that buoyancy should be enhanced by adding a manually inflatable life preserver. According to the manufacturer, this product is intended to provide flotation and hypothermia protection in the event of cold water immersion.

The MS2175 TC suit is equipped with a neoprene hood and 3-fingered lobster-claw-style gloves, which are stored in the 2 integral calf pockets. The suit's wrist and ankle cuffs are equipped with a hook-and-loop type attachment to allow for individual adjustment. The suit design allows for water ingress at the neck and at the wrist and ankle cuff locations.

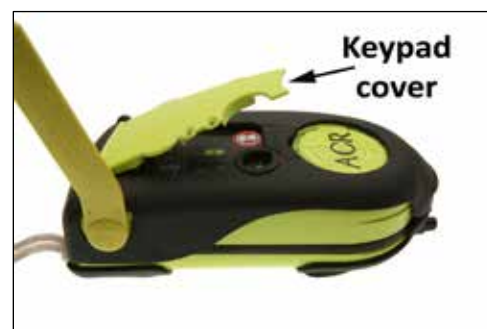
Figure 9. Aerofix 406 GPS/IO, model PLB-200

When initially provided to TSB investigators, the master's and scientist's PLBs were found stored in their PFD's right side pocket, whereas the pilot's PLB was found outside of the pocket, attached to the PFD via its lanyard. It could not be determined if the pilot had pulled the PLB out of the pocket or if it had been accidentally pulled out during or after recovery.

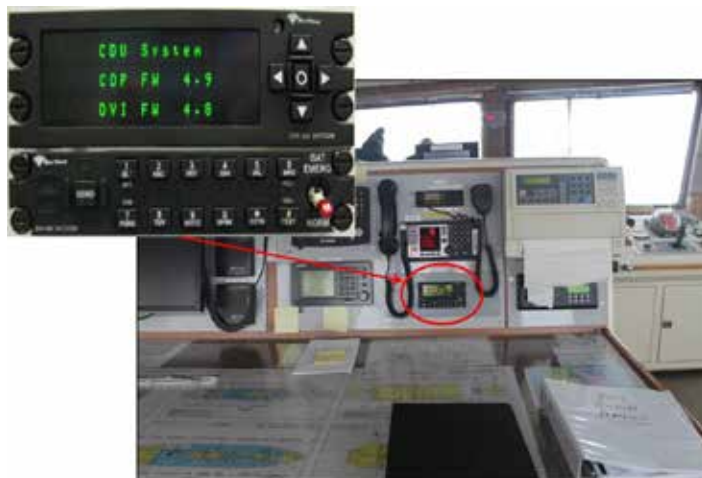
Figure 10. Location of FFS CDU user interface at chart table

At the time of the occurrence, the *Shipboard Helicopter Information and Procedures Manual* had not been updated to reflect the use of the new FFS, which was still in the development phase. According to the manual, the responsibility for monitoring the NavLink equipment during flight operations rests with the officer of the watch. Pending amendment to the manual, the CCG issued the Operations Circular (OC 07-2013) in June 2013, which outlined standard operating procedure (SOPs) for the use of the new FFS.

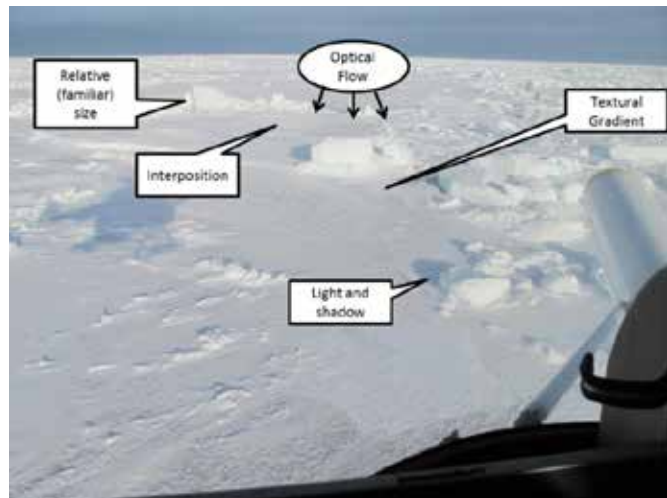
Figure 12. Visual cues available to assist in height keeping (still image taken approximately 10 minutes before the occurrence)

Figure 12 illustrates examples of the visual cues available for height keeping during an ice measurement flight. The pilot needs to maintain a continual scan in 3 areas: the near visual field, the distant visual field and the aircraft instruments—particularly the ice probe radar altimeter and the airspeed indicator. The relative importance of each area depends on cues available and the pilot would need to adjust the scan to focus more attention on the instruments in areas where there are fewer visual cues available outside the aircraft.

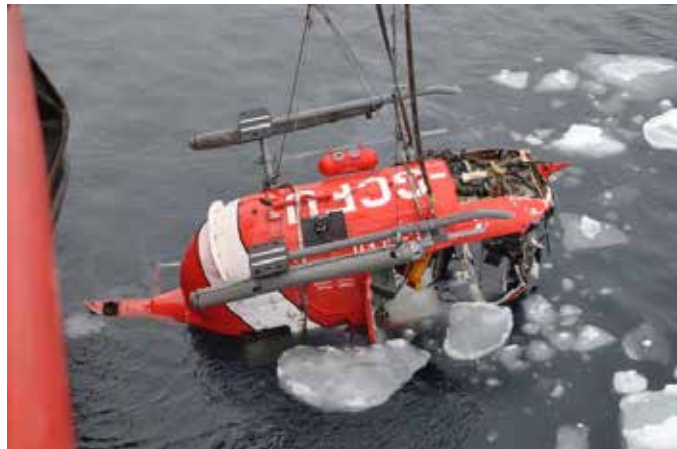
Photo 8. Wreckage recovery

At 0858, the ROV reached the mooring kit, wrapped the lanyards around the helicopter landing gear mounts and attached it to a Kevlar rope that was used to raise the wreckage to the surface and place it on the front deck of the CCGS *Amundsen* at 1430 (Photo 8).
