AVIATION INVESTIGATION REPORT A15H0002

Collision with terrain

Air Canada

Airbus Industrie A320-211, C-FTJP

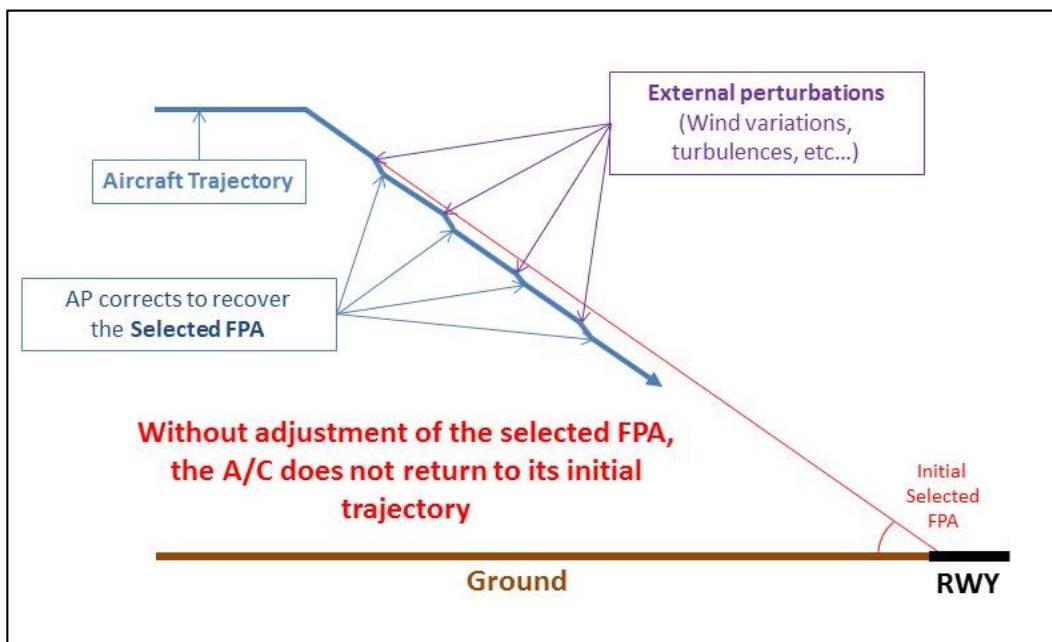
Figure 15. Example of flight profile with flight path angle (FPA) affected by perturbations (Source: Airbus Industrie)

When flying with the FPA guidance mode, external perturbations, such as wind variations or turbulence, can cause the aircraft to move away from the selected FPA initial approach path. If these perturbations result in momentary changes to the aircraft’s vertical trajectory,⁸² then the autopilot will recover the selected FPA, effectively paralleling the initial trajectory (Figure 15).

If the perturbations cause the aircraft to move below the initial approach path, then once the autopilot captures the selected FPA, the aircraft will continue to descend, but on a flight path that is below and parallel to the initial approach path. If these perturbations continue throughout the descent and the flight crew makes no adjustments to recover the initial approach path, then the altitude discrepancy between the initial and actual flight paths will continue to increase, resulting in the aircraft flying below the published approach vertical profile. This actual flight path will result in a low indication on the airport's approach slope indicators. A go-around must be initiated unless the flight crew estimates that only small corrections are necessary to rectify minor deviations from stabilized conditions.

The Airbus FCOM does not offer guidance on how to make adjustments to the FPA; for example, it does not indicate how large the adjustment should be or for how long the adjustment should be made in order to return an aircraft to the selected flight path. For a flight in FPA guidance mode, Air Canada's practice was that, once the aircraft was past the FAF, the flight crews were not required to monitor the aircraft's altitude and distance from the threshold, nor to make any adjustments to the FPA.
