AIR TRANSPORTATION SAFETY INVESTIGATION REPORT A18Q0186

COLLISION WITH TERRAIN

Eurocopter EC120B (helicopter), C-FSII
Sainte-Agathe-des-Monts, Quebec, 5 NM W
19 November 2018

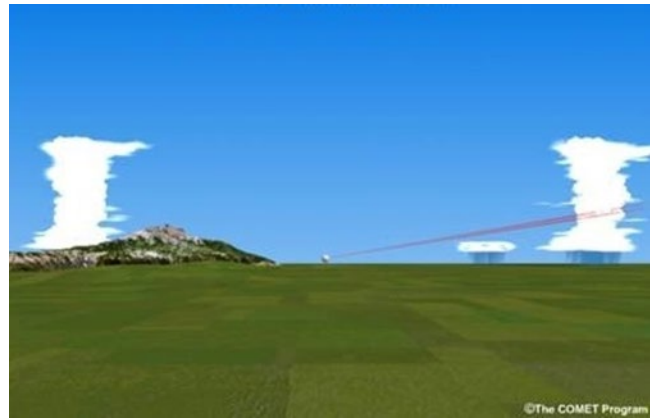
Figure 1. Schematic showing radar beams' limits of detection of precipitation (Source: The COMET Program of the University Corporation for Atmospheric Research, U.S. National Oceanic and Atmospheric Administration)

Also, the radar closest to the accident site was not working that day. Precipitation data were therefore collected using nearby radar sites to create a composite image (Appendix D). However, radar beams do not detect all precipitation occurring below the beams (Figure 1). It was therefore impossible to accurately determine whether precipitation was present or absent.
