AIR TRANSPORTATION SAFETY INVESTIGATION REPORT A19Q0109

MAIN ROTOR BLADE FAILURE IN FLIGHT

Robinson R44 (helicopter), C-FJLH

10 July 2019

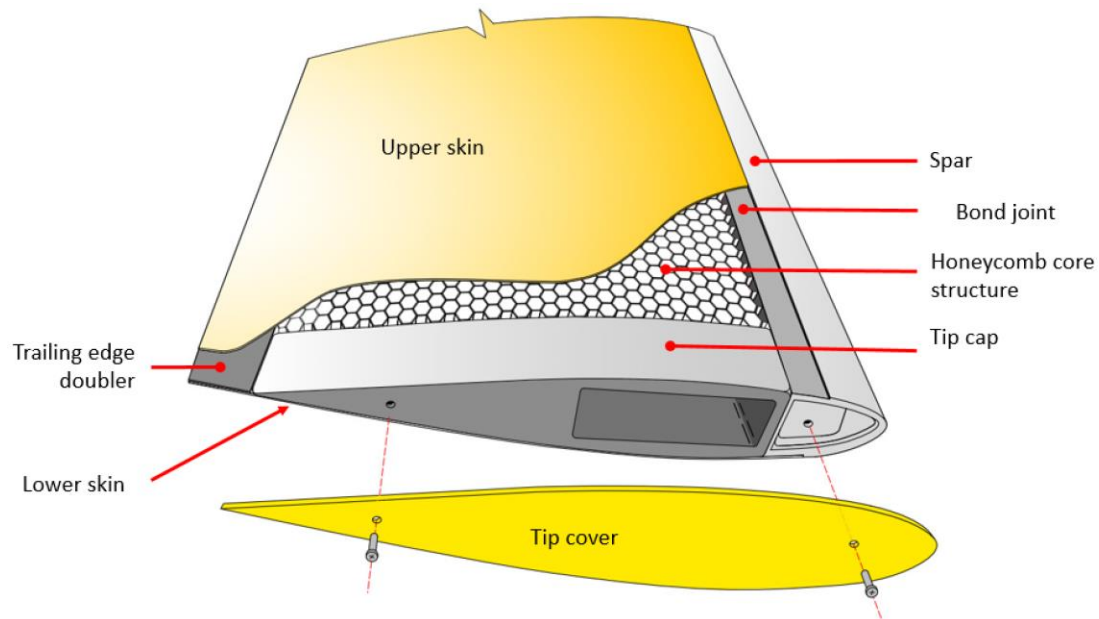
Figure 2. Components of a C016-2 main rotor blade (Source: TSB)

These blades had a known tendency to debond⁶ at the adhesive bond joint between the skin and the spar at the tip of the blade. Skin debonding can occur when the adhesive bond joint becomes exposed as a result of the top coat eroding or when corrosion appears below the internal aluminum tip cap. A blade is not considered airworthy if debonding, including microperforation, is detected along the bond joint.⁷

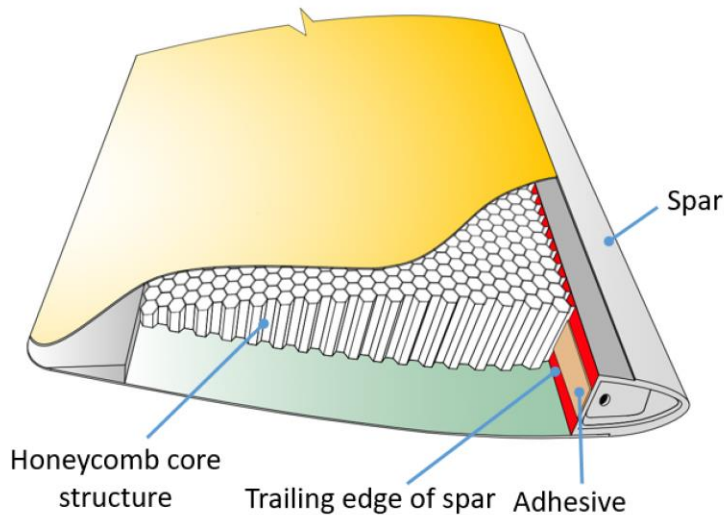
When the blades are manufactured, the upper skin and lower skin are overlaid at the bond joints along the spar, the trailing edge doubler and the tip cap, and held in place with a sprayed adhesive. The honeycomb core structure is also bonded to the trailing edge of the spar with the adhesive to ensure the solidity of the rotor blade (Figure 4).

Figure 4. Diagram showing where the adhesive is applied between the trailing edge of the spar and the honeycomb core structure (Source: TSB)

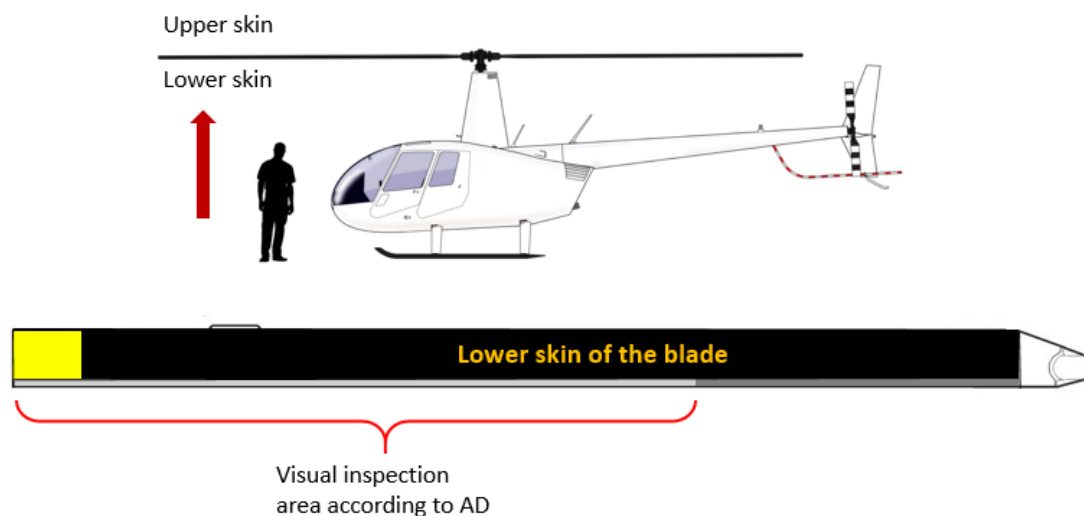
(Figure 5). The visual inspection could be performed by someone who had at least a private pilot licence and it had to be entered into the aircraft records.

Figure 5. Area of the lower skin on a blade to visually inspect (Source: Robinson Helicopter Company website [<https://robinsonheli.com/>] for the helicopter and TSB for the blade and annotations)

- If there is any exposed metal surface at the joint, an inspection should be conducted by an aircraft maintenance engineer (AME) in accordance with Service Bulletin SB72, issued by RHC, before each flight.
- Regardless of their condition, all blades had to be taken out of service and replaced with blades bearing a different part number, depending on the helicopter model, by 09 January 2020.

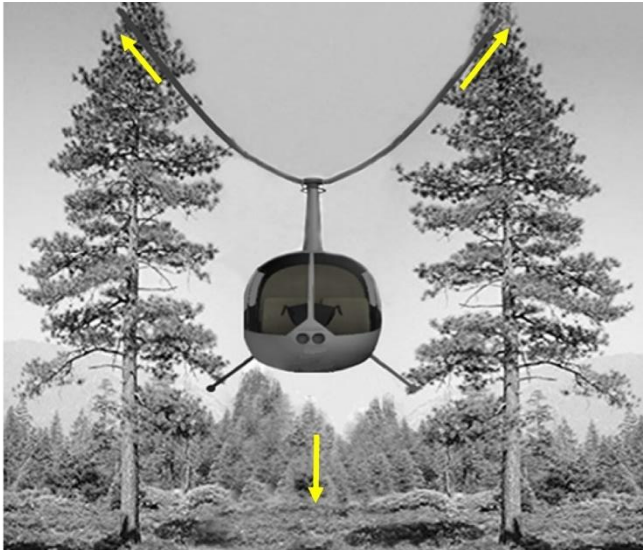
If a helicopter descends through trees while the main rotor is not turning, it is likely that the blades will undergo excessive upward bending from the pressure of the branches. This excessive bending causes deformations by compression of the upper skin only, meaning the upper side of the blade. The lower skin should show signs of scratches, nicks or dents from contact with branches (Figure 8).

Figure 8. Illustration of the interaction between immobile main rotor blades and trees during a vertical drop (Source: TSB)

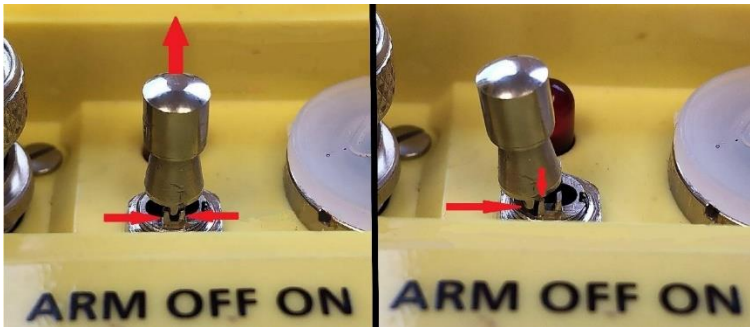
The locking system of the occurrence ELT model was designed such that a prong, aligned with the centre of the switch, is blocked by a locking latch on either side to prevent it from moving from one position to another. To move the switch, it must be pulled up to disengage the switch prong from the latches and set it to the desired position (Figure 13).

Figure 13. ELT switch locking system similar to the system in the occurrence (Source: TSB)

A more thorough examination of the occurrence ELT revealed that the locking latches between the OFF position and the ARM position were broken (figures 14 and 15). Furthermore, the examination showed that the fracture surface of these latches was smooth, indicating that the switch had moved several times between the OFF position and the ARM position over time.
