AIR TRANSPORTATION SAFETY INVESTIGATION REPORT A2200140

COLLISION WITH TERRAIN

Privately registered
Quad City Ultralight Aircraft Corporation
Challenger II (advanced ultralight), C-IYDD
Westport/Rideau Lakes Aerodrome, Ontario, 11 NM WSW
24 September 2022

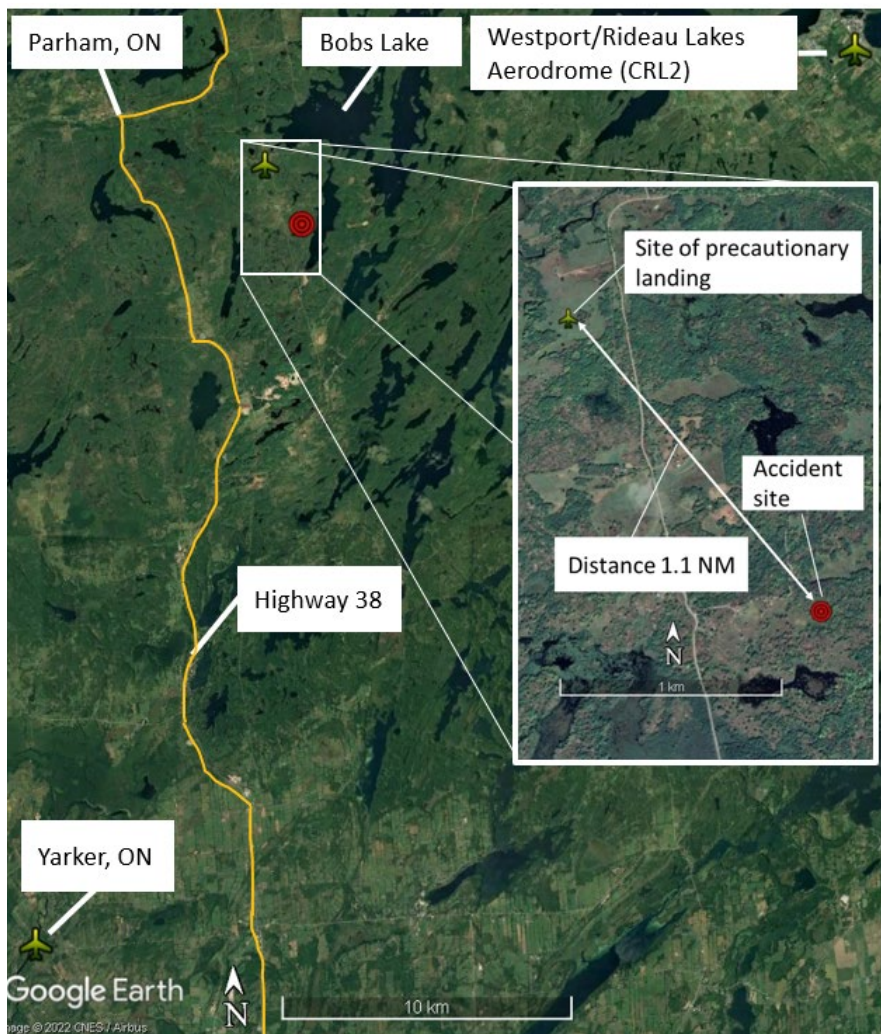
Figure 1. Map showing the site of the precautionary landing and the accident site (inset) (Source: Google Earth Pro, with TSB annotations)
