MARINE INVESTIGATION REPORT

M01C0029

SWAMPING AND CAPSIZING

FISHING VESSELS *SHANNON DAWN* AND *RACHEL M*

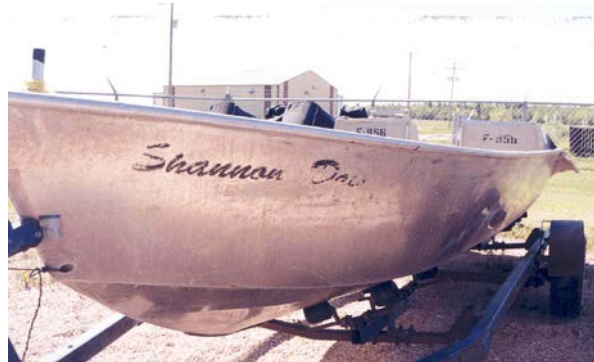
The *Shannon Dawn* was constructed from plans used by several area manufacturers. The plans were shown to Transport Canada inspectors, but due to the vessel size, were not subject to the Transport Canada plan approval process. The manufacturer of the vessel estimated that 300 to 400 vessels of similar design have been built by the facility. The vessel incorporated a hard chine and side plating, with a pronounced flare toward the bow. There was a breast plate

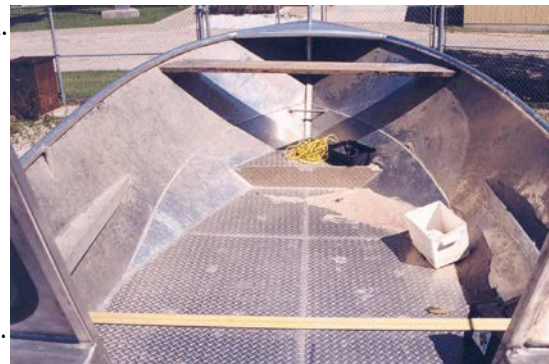
The *Rachel M* had these modifications incorporated in its hull. Since both small fishing vessels were less than 15 gross tons, neither vessel was required to be inspected by Transport Canada.

There is no requirement for navigational equipment to be carried on board vessels of this size and type. However, the vessels were each equipped with a VHF radiotelephone for communication. The VHF was mounted on the centre console.
