MARINE INVESTIGATION REPORT

M02W0089

CAPSIZING — TWO FATALITIES

LOG SALVAGE VESSEL *BRUCE BROWN*

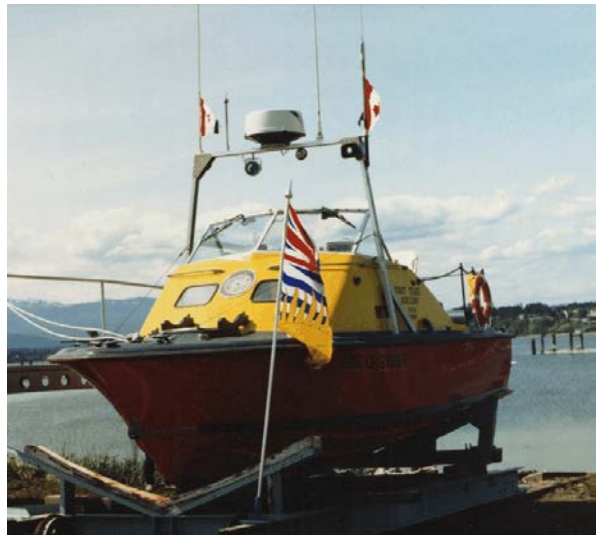
The *Bruce Brown* is a vessel less than 5 gross registered tons (GRT), of open construction. The deep v-shaped hull is constructed of moulded glass-reinforced plastic. An enclosed wheelhouse is located at the vessel's mid-length with an aft-facing door to starboard, leading to the open well deck. A cuddy cabin below the forward deck is accessed from the wheelhouse, but this is not, by definition, considered as "berthed accommodation." The well deck is contained by solid bulwarks approximately 0.5 m in height. Immediately aft of the wheelhouse on the centre-line of the well deck is the engine compartment of plywood construction. The forward end of the engine compartment is fitted with a non-watertight transverse bulkhead that does not extend vertically to the well deck. The engine compartment extends aft and has a raised coaming above the well deck to the height of the bulwarks. Aft and to each side of the engine compartment, in the form of a 'U' between the bulwarks, is deck space approximately 0.5 m wide. A 15 cm diameter towing post, forward of and extending 35 cm above the engine compartment, is located on the centre-line aft of the wheelhouse.

The engine compartment extends aft and has a raised coaming above the well deck to the height of the bulwarks. Aft and to each side of the engine compartment, in the form of a 'U' between the bulwarks, is deck space approximately 0.5 m wide. A 15 cm diameter towing post, forward of and extending 35 cm above the engine compartment, is located on the centre-line aft of the wheelhouse.

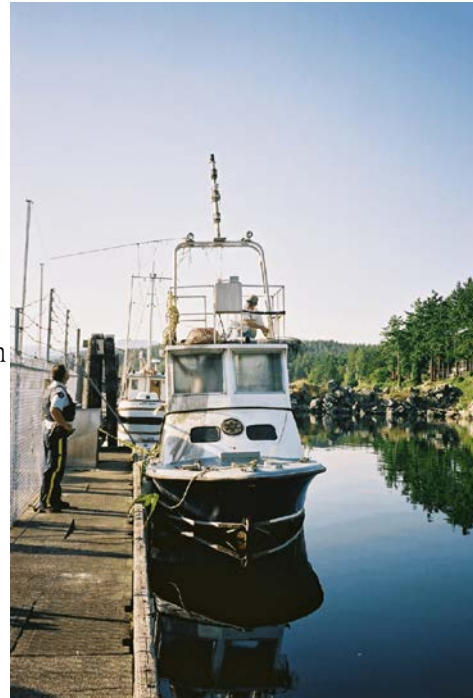
In January 1968, as a vessel of closed construction, the vessel entered government service for hydrographic duties, was named *Petrel*, and received its licence number. The Comox Valley Marine Rescue Society acquired the *Petrel* in April 1988, and re-named the vessel *Bruce Brown*. On 16 February 1998, the licence was transferred to the owner/operator, who purchased the vessel as a project for use in his retirement. The owner/operator modified the vessel with the intention of utilizing it for commercial log salvage. These modifications included replacing the enclosed after deck with an open well deck; extending the vessel's superstructure significantly above that of its initial construction; fabricating an enclosed wheelhouse; adding a control station above the wheelhouse; and fitting a metal arch and mast for navigation lights, deck lights, and radio antennae, with a resulting air draft above 6 m.

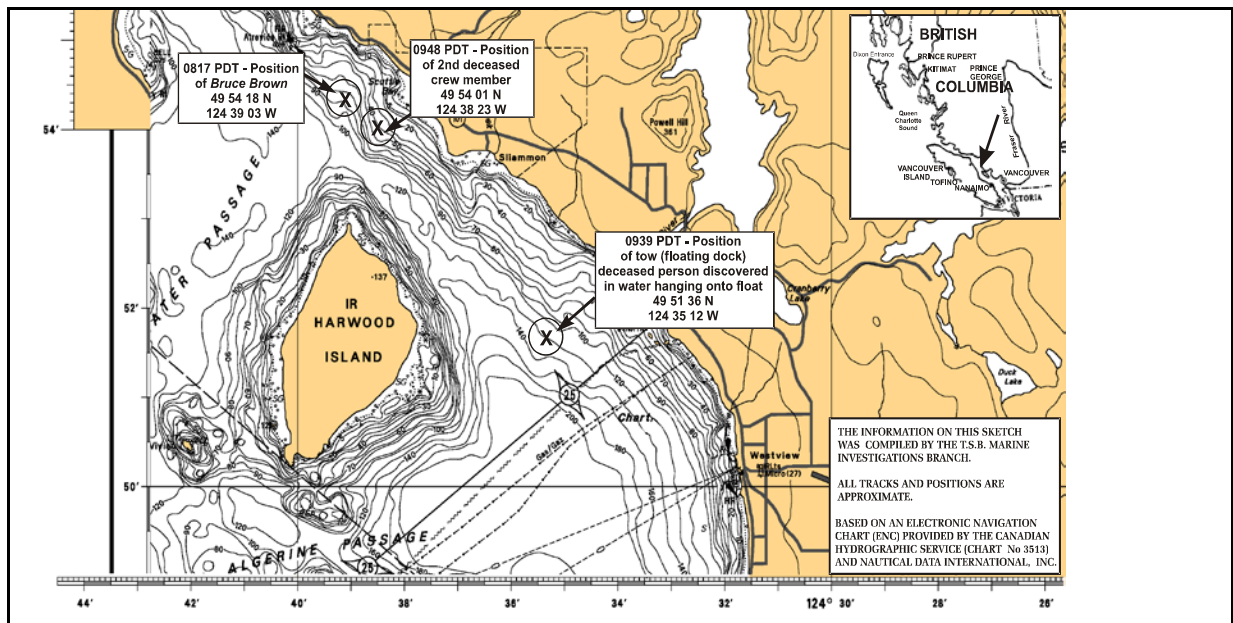
At 0817, the *Mallard* advised the JRCC of the position of the capsized vessel by the relay of Global Positioning System coordinates. At that time, the vessel was located nine cables southeast of Atrevida Reef light (List of Lights No. 477.5). Five minutes later, the *Mallard* reported that the vessel was the *Bruce Brown*. At 0901, the *Mallard* reported to the JRCC that it had the *Bruce Brown* in tow for Scuttle Bay. The *Bruce Brown* was recovered by trailer from Scuttle Bay later that same day.
