## MARINE INVESTIGATION REPORT

M03M0077

### FIRE AND SINKING

SMALL FISHING VESSEL *SILENT PROVIDER*

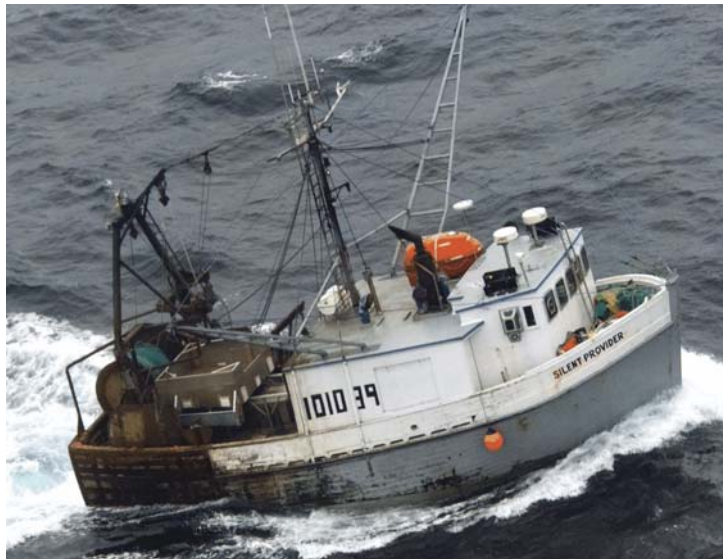
**Photo 1.** Fishing Vessel *Silent Provider*

The *Silent Provider* eventually burned to the waterline and sank. It was declared a total loss.

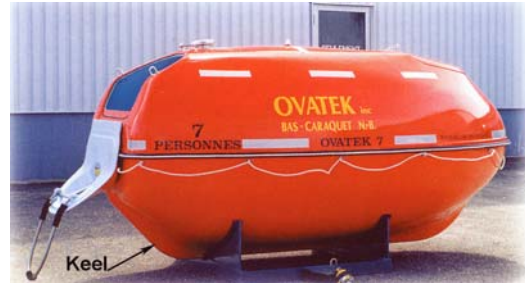
**Photo 3.** Ovatek 7

left from the evaporating water remain imbedded in the fabric. In contrast, the Ovatek 7 does not have water pockets. It has an internal ballast arrangement whereby seawater enters openings in the hollow fibreglass keel.

To launch an Ovatek 7, the liferaft is pivoted on the stowage cradle and pushed over the side bow first. The stowage cradle has an athwartships notch that accommodates the liferaft's keel and facilitates the launch procedure. To launch the flat-bottomed Ovatek 4, it must be lifted from its storage cradle and thrown overboard by two people to avoid damaging the underhanging water pockets.
