MARINE INVESTIGATION REPORT
M03N0050

FIRE ON VEHICLE DECK

ROLL-ON/ROLL-OFF PASSENGER FERRY
JOSEPH AND CLARA SMALLWOOD
8 NAUTICAL MILES SOUTH OF PORT AUX BASQUES,
NEWFOUNDLAND AND LABRADOR
12 MAY 2003

Report Number M03N0050

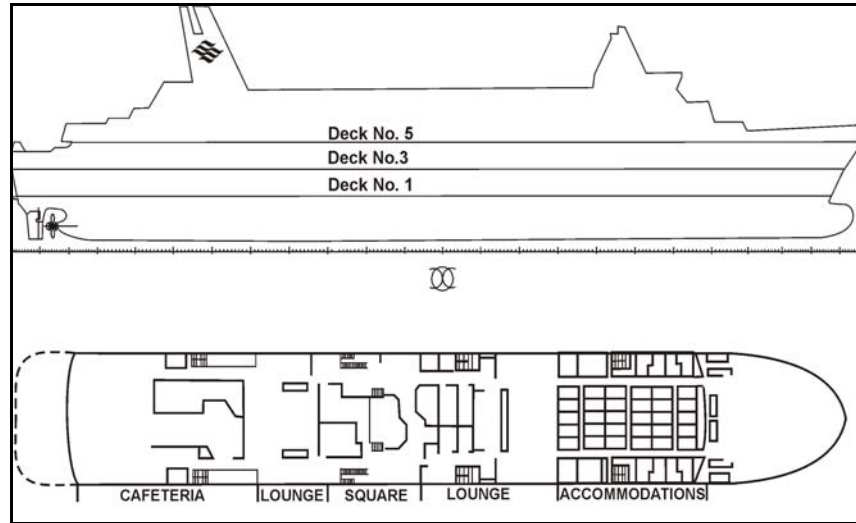
Figure 2. Deck 5

At approximately 2330, the master contacted the senior chief steward (SCS) and was advised that there was smoke in the forward section of deck 5. As a result, all passengers were directed to muster in the cafeteria by means of a PA announcement. At 2340, a second PA announcement requesting all passengers to muster in the cafeteria was made. Shortly thereafter, the master contacted the SCS with the procedure to be followed for evacuating passengers once they arrived at Port aux Basques.
