MARINE INVESTIGATION REPORT

M15P0286

Capsizing and loss of life

Fishing vessel *Caledonian*

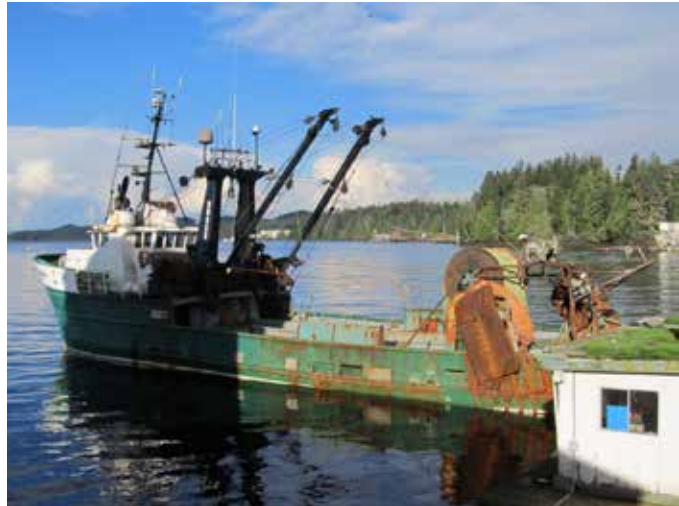
Photo 3. *Caledonian* moored in Port Hardy, April 2015

and compare it to the lightship weight that had been determined by the 1976 inclining experiment. Using Photo 3 below, the draft of the vessel, its total weight, and an estimated lightship weight were determined. The lightship weight of the vessel in April 2015 was estimated to be 327 tons, which represents an increase of over 18% compared to the lightship weight in 1976, which was 276 tons.
