MARINE TRANSPORTATION SAFETY INVESTIGATION REPORT M18P0014

ENGINE ROOM FIRE

Container vessel *MOL Prestige*

31 January 2018

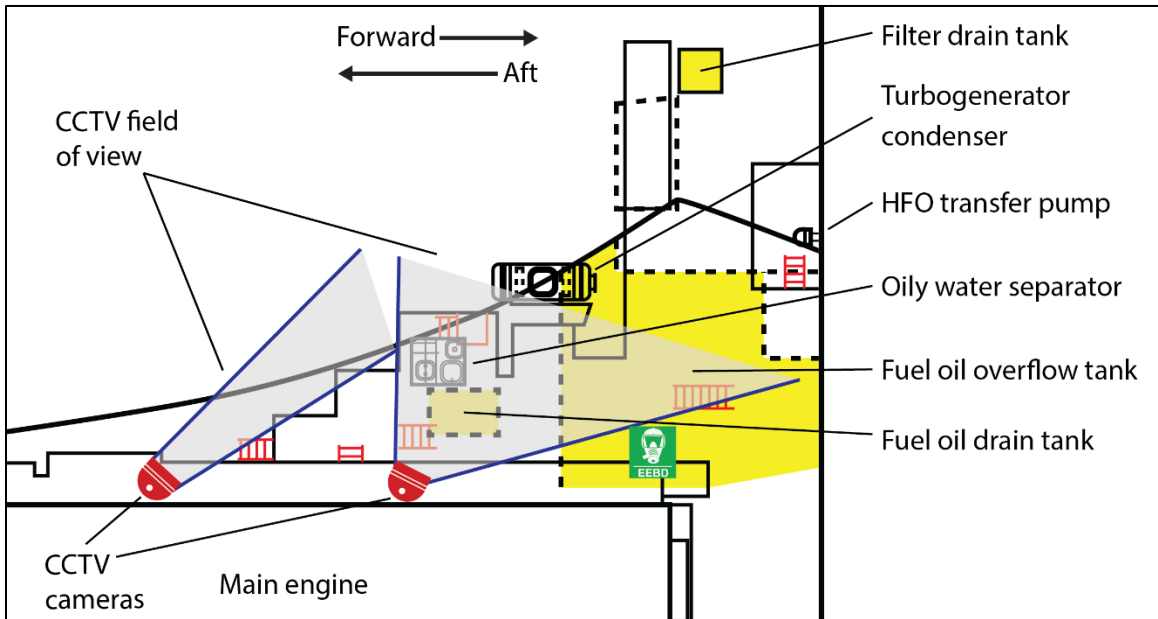
Figure 6. Locations of closed-circuit television cameras on Deck 4 and their field of view (Source: TSB)

The second engineer ordered motorman 1 to check the decks below. At 2118:06, the CCTV captured footage of oil spraying onto the oily bilge water separator located on the bottom deck. Motorman 1 exited the ECR and was partly down the stairs from deck 2 to deck 3 when smoke and flames were observed on deck 3 near the auxiliary boiler area. He returned to the ECR and informed the second engineer. The junior engineer informed the second engineer that he had inadvertently turned off the boiler circulating pump on deck 4. The junior engineer then exited the ECR through the starboard-side door and restarted the pump at 2118:34. At 2118:39, burning oil and flames were observed near the stairs between deck 3 and 4, close to the No. 3 generator.²⁸ Soon after, the engine room started rapidly filling with black smoke. At 2119:05, the junior engineer rushed back into the ECR. At this time, the generator frequency also began fluctuating.

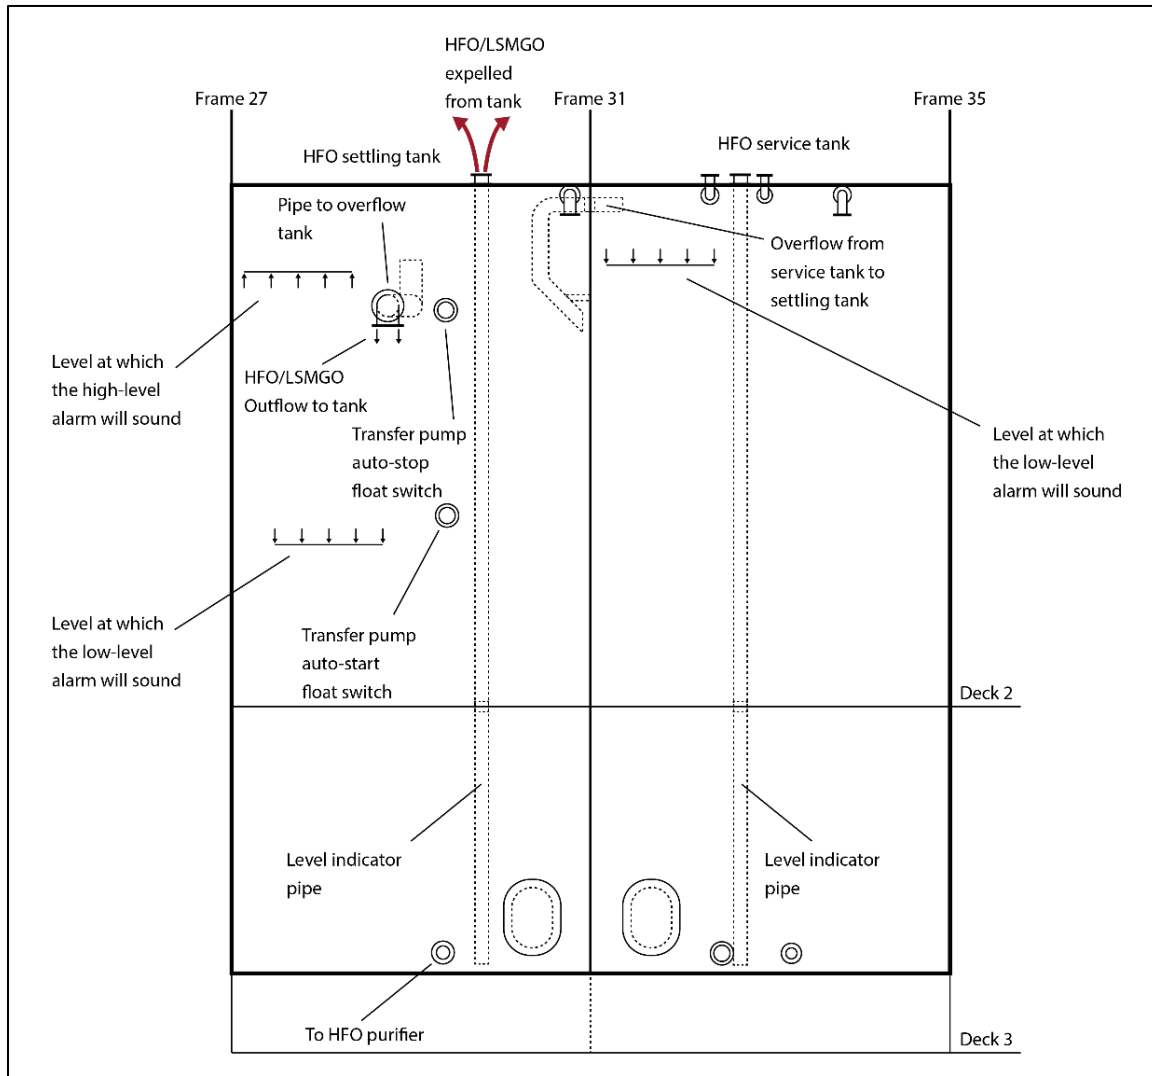
Figure 13. Settling and service tanks, cross-section view (Source: TSB, based on the tank schematics)

The settling tank was normally maintained at a temperature of 85 °C. It had a local temperature gauge and a high-temperature detector that was designed to sound an alarm in the ECR when a temperature of approximately 90 °C was detected. Before the occurrence, the seat of the valves for the steam heating coils was leaking steam, and the steam was passing through the valves even when they were closed, continuously heating the settling tank's content.

At the time of the occurrence, the temperature of the HFO in the settling tank was 120 °C. Following the occurrence, the TSB examined the alarm logs from 15 January until the day of the occurrence and found that the high-temperature alarm for the settling tank had activated on 26 January on the engine room alarm panel. The TSB could not determine if the HFO settling tank temperature was checked or whether any other action was taken as a result of the alarm.

The top of the tank had originally been fitted with a float-type indicator⁵⁶ that continuously transmitted information about the level of the tank to a monitor on the tank bulkhead. The monitor visually indicated the levels and sounded alarms in the ECR when the tank contents reached high or low levels (Figure 14). On the settling tank, the indicator had been fitted by a flanged connection to a pipe 10 cm in diameter that extended to the tank bottom. The wire and float for the indicator moved up and down inside this pipe. At some point, the indicator had been removed for repair or replacement, and the pipe opening had been covered with a blind flange.⁵⁷ The tank did not have a designated sounding pipe to take manual soundings.

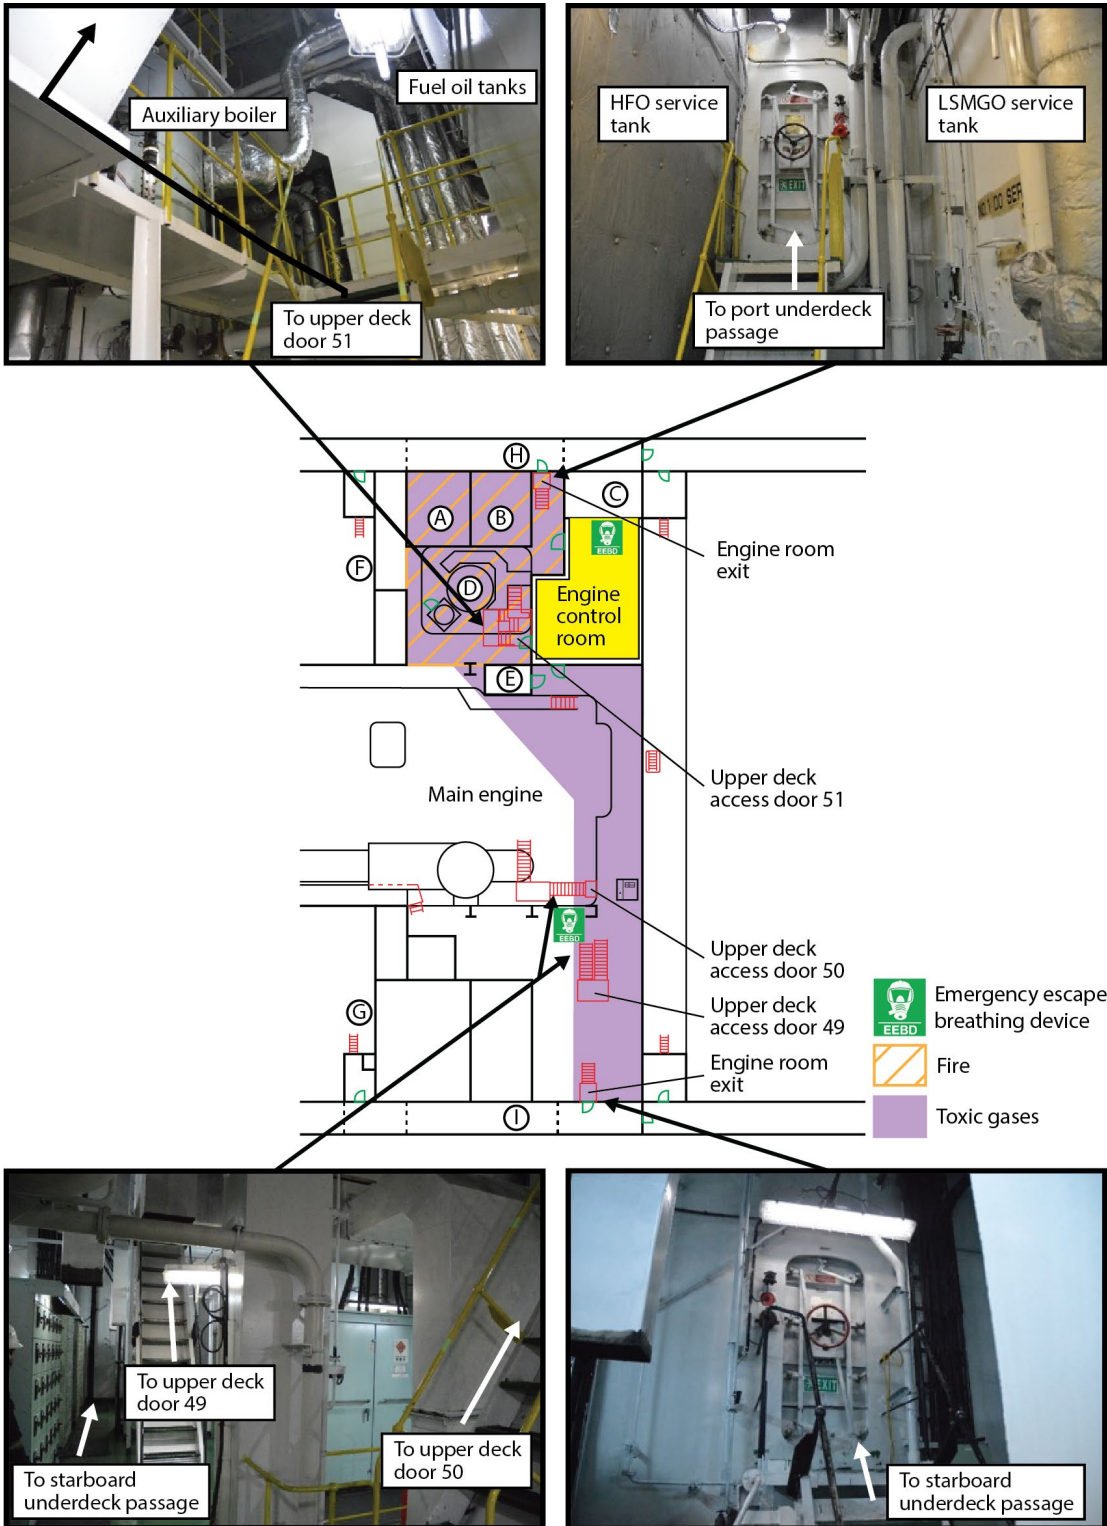
The closest exit from the engine room was the door to the port underdeck passage. The second-closest exit was door 51. Doors 49 and 50, as well as the door to the starboard underdeck passage, were approximately 20 m from the ECR (Figure 20).

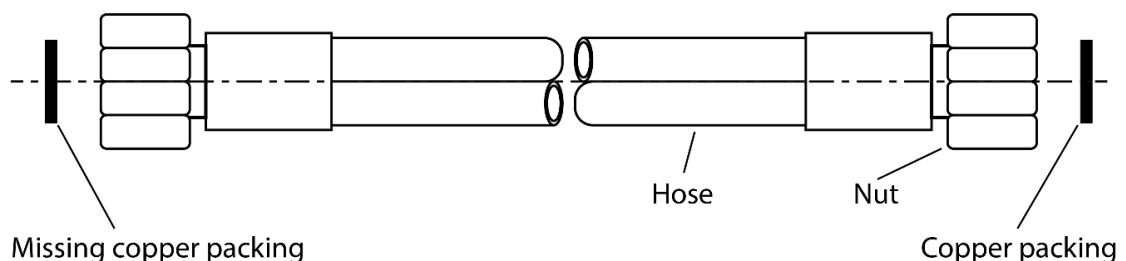
Figure 24. CO₂ cylinder hose (Source: Original equipment manufacturer manual, with TSB annotations)

- A fitting that connected the line from the time-delay unit to the actuation lines of the engine room cylinders was loose where it was secured on the time-delay unit and was leaking heavily in the CO₂ room.
- As a result of the leak, at least 70 cylinders furthest from the time-delay unit were deprived of the necessary actuating pressure, and these cylinders did not release their CO₂.
- Two of the check valves in the actuation line were leaking inside the CO₂ room.
- Copper tubing runs from the remote-release cabinets at the fire station, through the engine room, to the CO₂ room; this tubing was damaged.
- A number of copper packings were missing from the CO₂ cylinder hoses, and the hoses were leaking CO₂ in the CO₂ room (Figure 24).
