MARINE TRANSPORTATION SAFETY INVESTIGATION REPORT M19P0029

GROUNDING

Search and rescue vessel (*Spirit of Sooke*)

07 February 2019

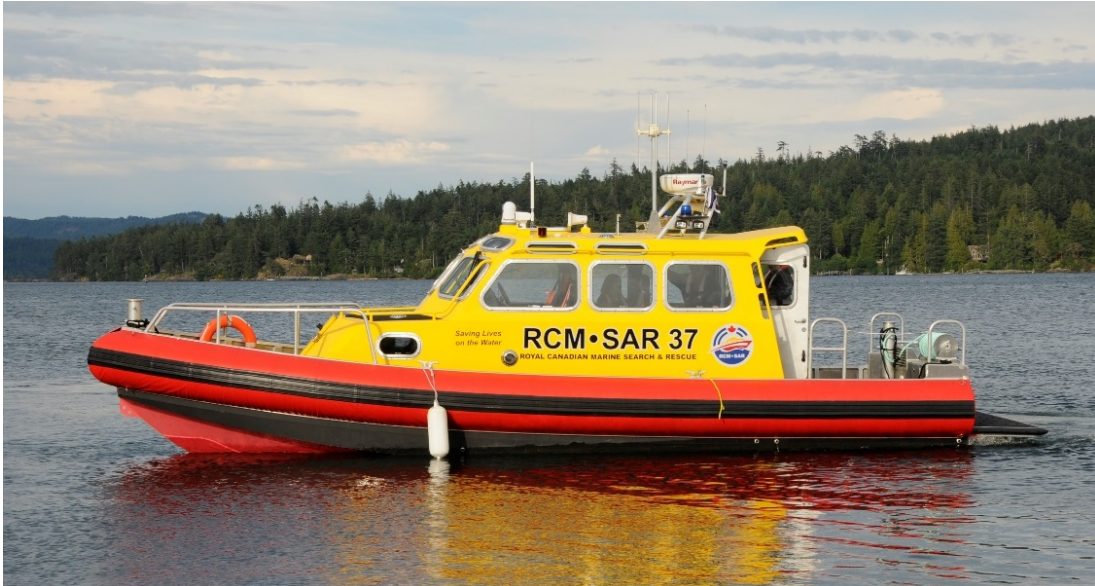
Figure 1. Spirit of Sooke (Source: Royal Canadian Marine Search and Rescue Station 37)

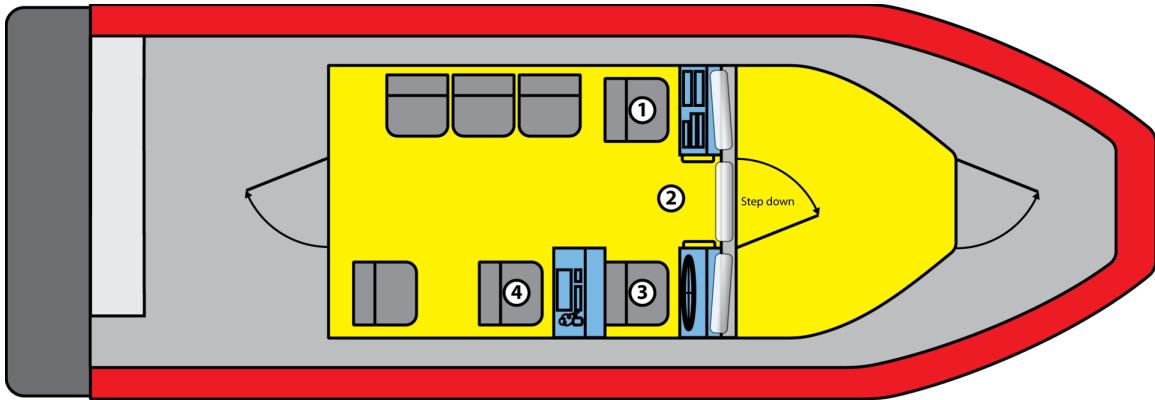
Figure 2. *Spirit of Sooke* cabin layout. (1) Navigation station; (2) standing lookout station; (3) helm station; (4) communications station. (Source: TSB)

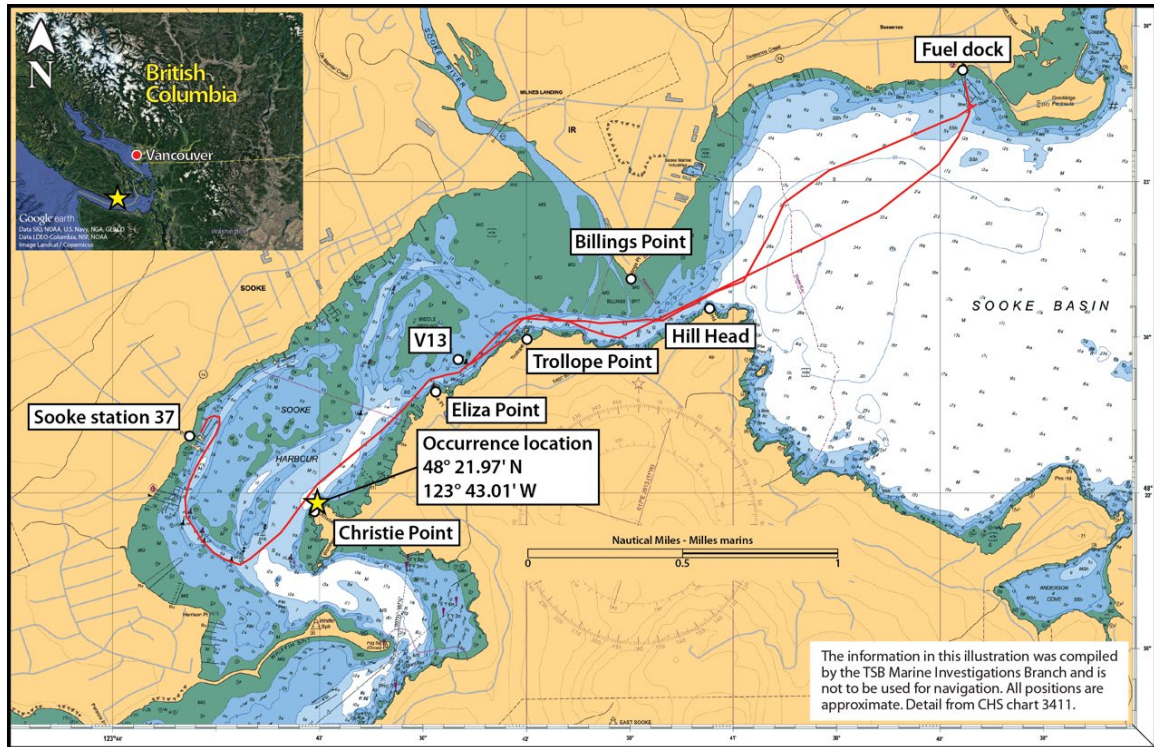
Figure 3. Area of the occurrence and the Spirit of Sooke's route (Source: Canadian Hydrographic Service with TSB annotations)

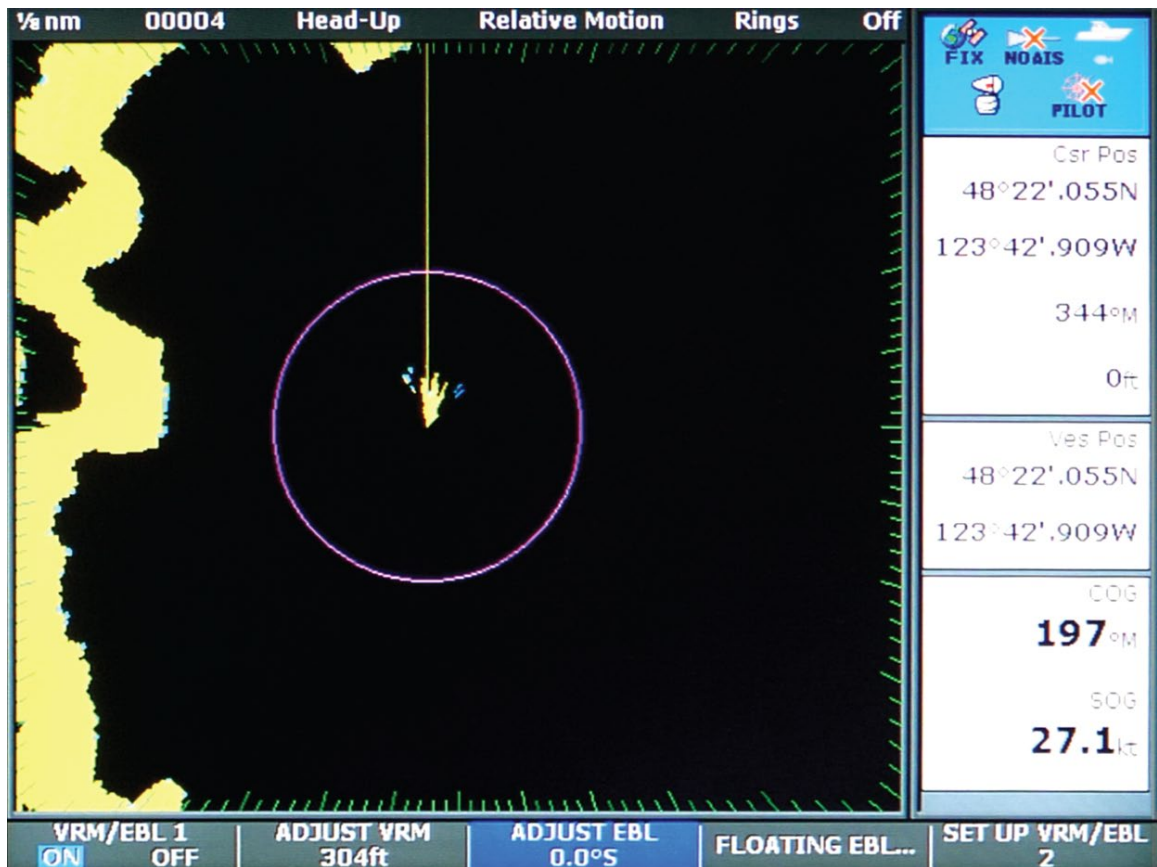
Figure 6. Radar display in head-up mode. The purple ring is a 0.05 NM variable range marker.
 (Source: TSB screenshots of RCMSAR/CCG simulation videos)

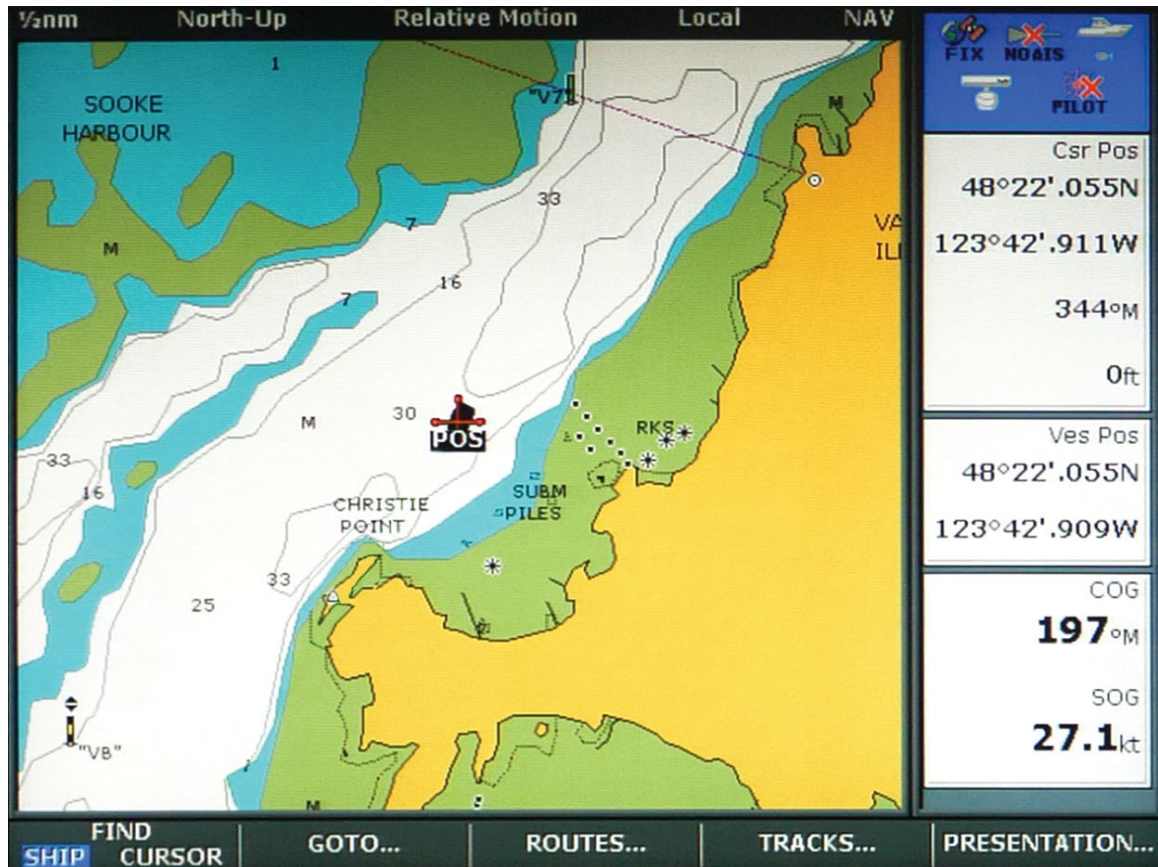
Figure 7. Chart plotter display in north-up mode. The vessel icon indicates the direction that the vessel is travelling. (Source: TSB screenshots of RCMSAR/CCG simulation videos)
