MARINE TRANSPORTATION SAFETY INVESTIGATION REPORT M22C0005

MOORING ACCIDENT

Roll-on/roll-off ferry *Madeleine II*
Cap-aux-Meules, Quebec
09 January 2022

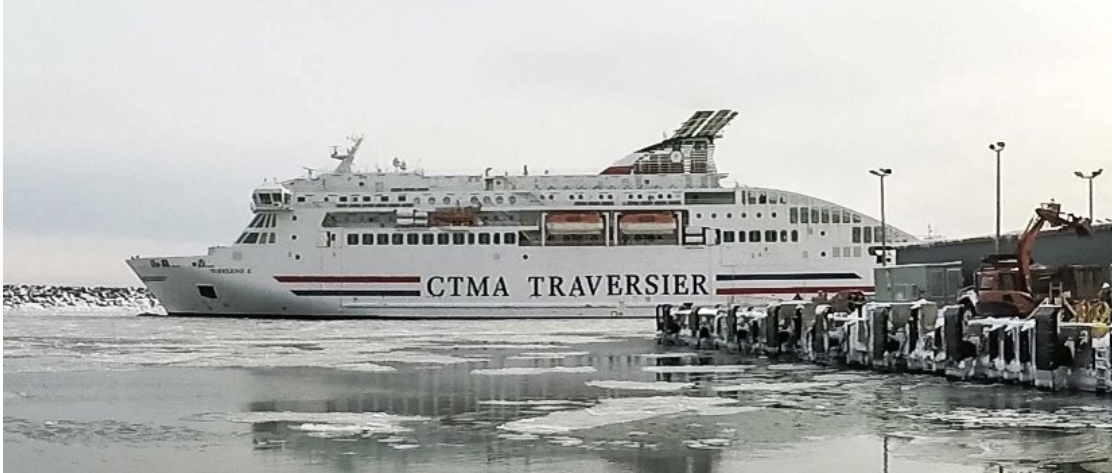
Figure 1. Roll-on/roll-off ferry *Madeleine II* in Cap-aux-Meules, Quebec (Source: TSB)

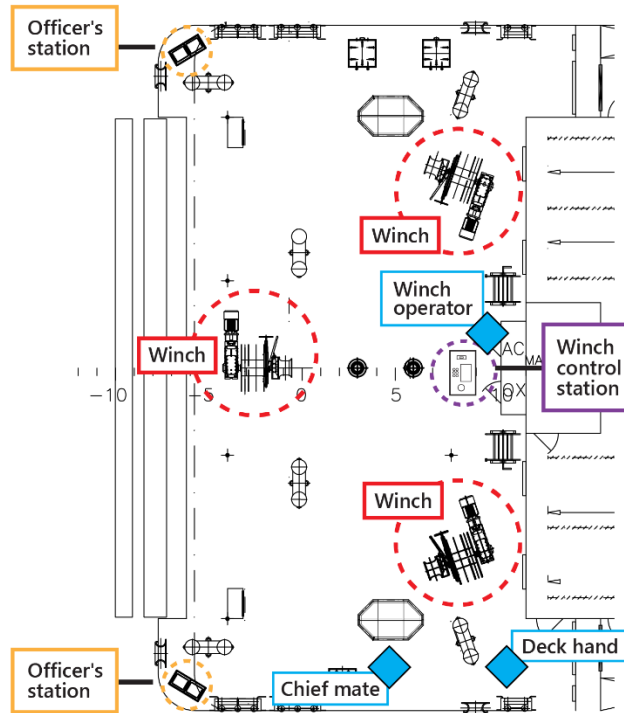
The aft mooring station (Figure 2), completely covered by a steel roof, comprises 2 winches installed on either side of the vessel and a 3rd installed in the centre of the deck near the aft

bulwark. The winch control station is located in the middle, near the accommodation area. Two positions, which are elevated and protected by steel walls, one on each side of the vessel aft, are provided for the officer in charge.

Figure 2. Diagram of aft mooring station
(Source: Coopérative de Transport Maritime et Aérien,
Madeleine II plan, with TSB annotations)

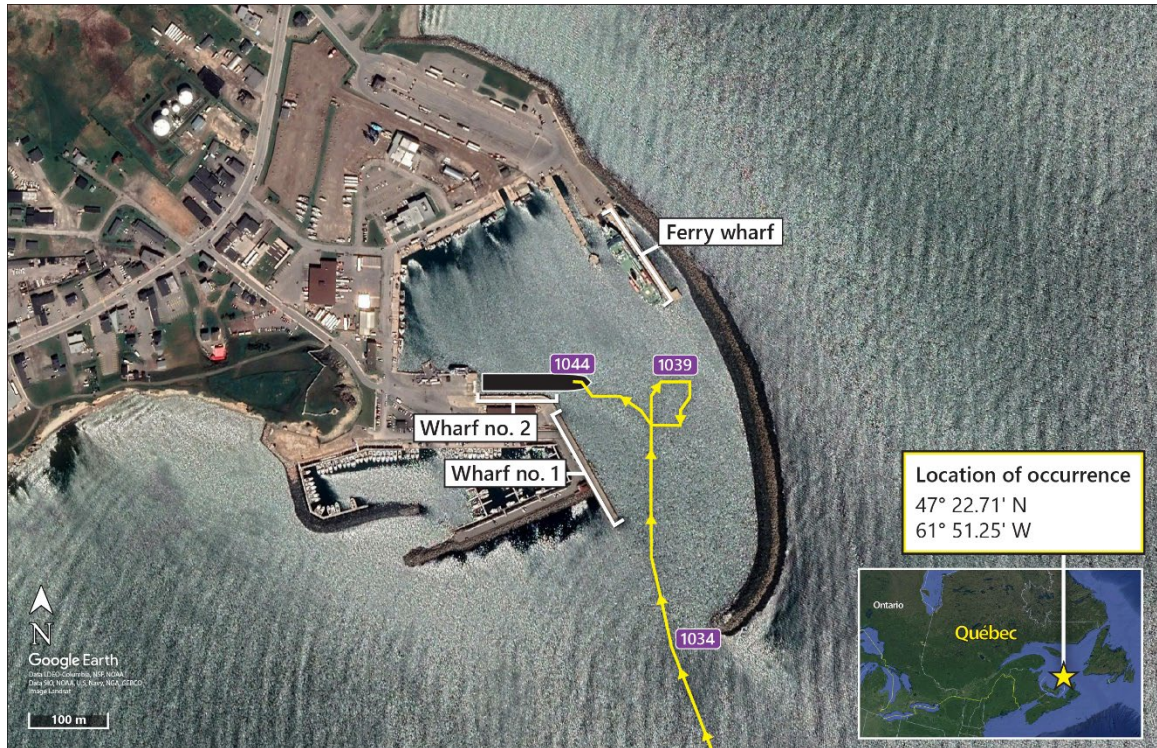
At 1034, the vessel entered the port (Figure 3), and its speed was reduced to 4.1 knots. The bow and stern mooring teams went to their respective stations. The third officer was in charge of the forward mooring station, with the bosun operating the winches, plus 2 deckhands and 1 deck cadet to look after the mooring lines. The chief mate was in charge of the aft mooring station, assisted by a winch operator⁶ and a 2nd deckhand to handle the mooring lines. The second officer was at the vehicle loading ramp controls at the stern of deck 3. The chief mate, second officer, and third officer communicated with the master via portable ultra-high frequency (UHF) radiotelephones. The master informed the mooring crews that the forward breast line and 2 aft spring lines would be deployed first.

Figure 3. Aerial view of Cap-aux-Meules harbour and recorded manoeuvre of the *Madeleine II* during this occurrence, with times indicated (Source: Google Earth, with TSB annotations)

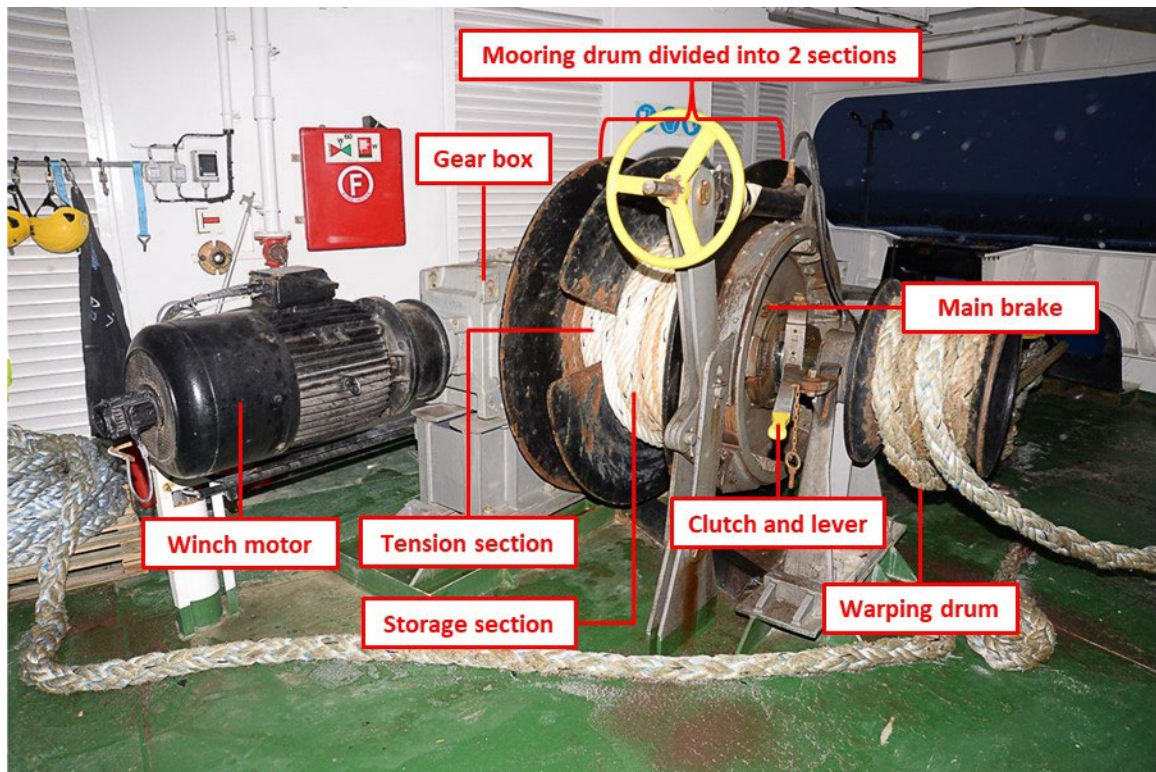
The winch consists of an electric motor connected to a drive shaft via a gearbox. The drive shaft passes through a mooring drum divided into 2 sections (1 section for storage and 1 section for tensioning) and a warping drum (also known as a capstan head) at the outer end. A lever engages and disengages the mooring drum. The warping drum cannot be disengaged from the shaft. When the vessel is moored, the winch motor is switched off and the electromagnetic brake is applied. The main friction band brake is automatically activated through a hydraulic cylinder to immobilize the winch drum and secure the mooring lines. The shaft can then be disengaged in order for a 2nd mooring line to be used with the warping drum (Figure 5).

Figure 5. Starboard aft mooring winch (Source: TSB)

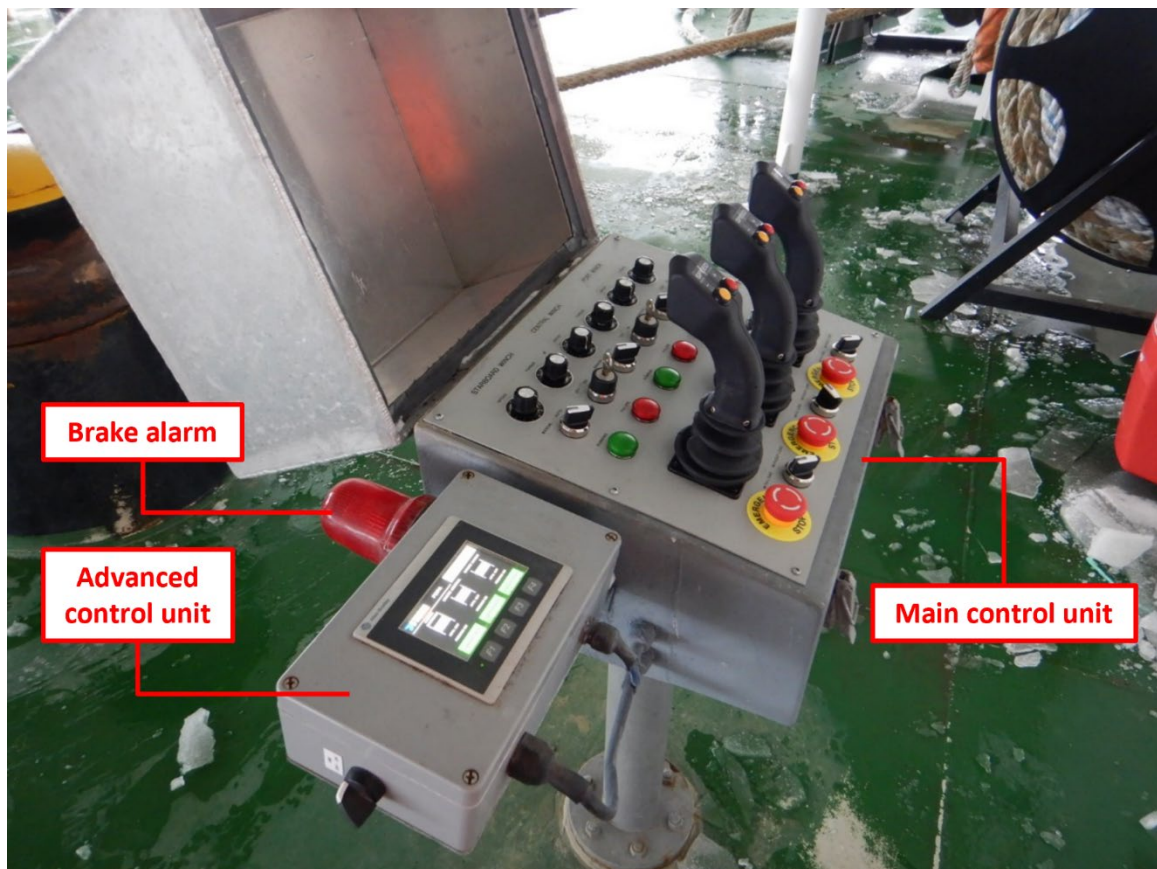
The winch control station comprises 2 units: the main control unit and the advanced control unit (Figure 6).

Figure 6. Overview of aft mooring winch control station (Source: TSB)

The advanced control unit has 2 alarm levels. When an anomaly is detected, a 1st alarm is triggered: the operator is warned by an alarm message in Spanish, an audible signal, and the flashing brake alarm light (Figure 6).
