Marine Occurrence Report

Fatal Injury to Crew Member

F.V. "CAPE BRIER"

Report Number M93M0006

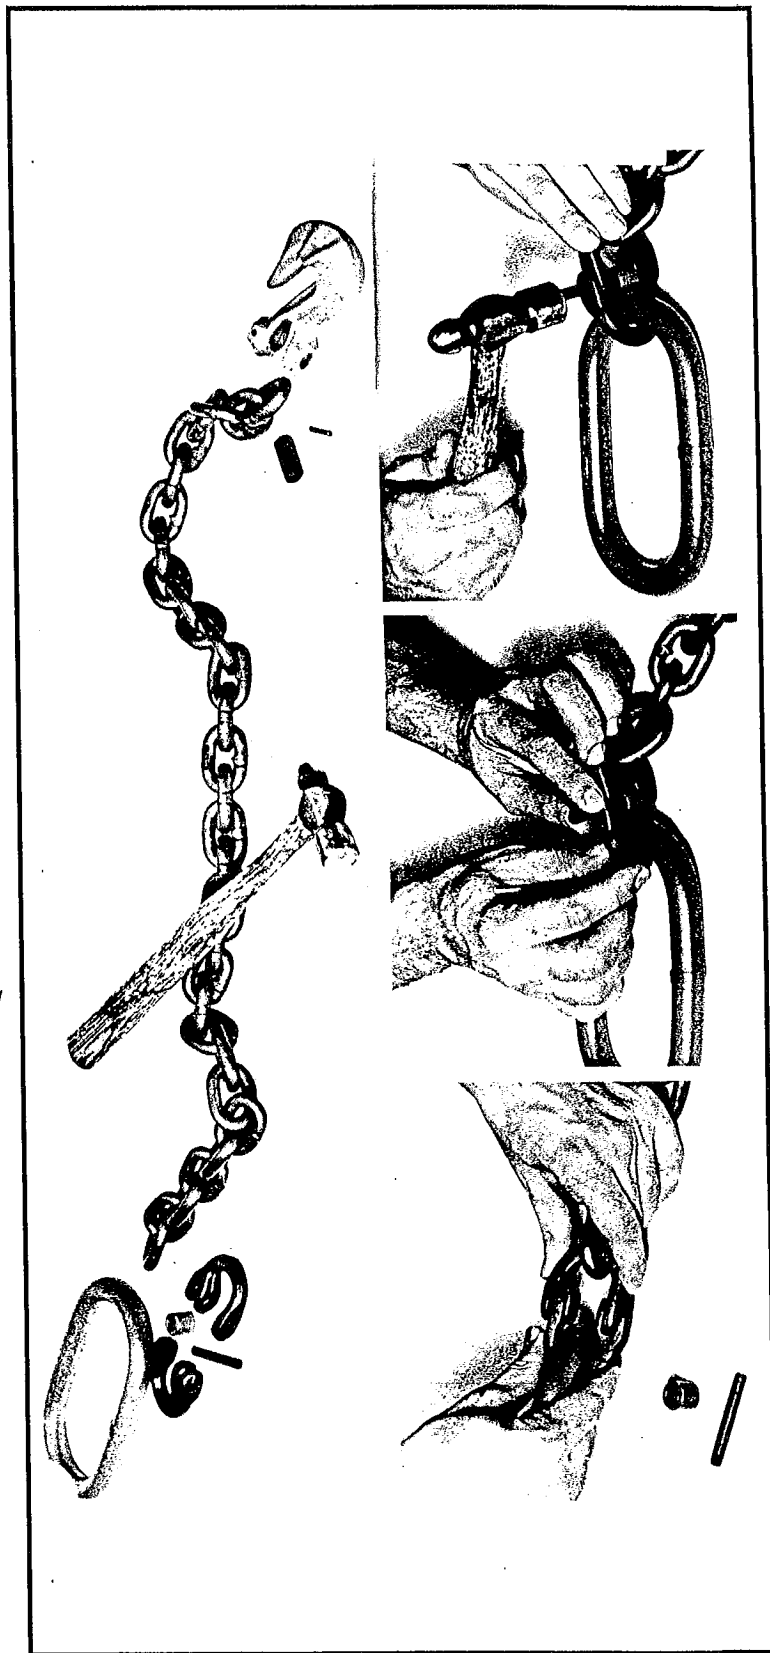
COUPLING LINK

Two 16 mm (5/8-inch) coupling links and chain samples from the mid-water trawl door securing arrangement were sent to the TSB Engineering Laboratory for analysis. The two coupling links from the securing arrangement and a new coupling link of the same size were tested to destruction. The laboratory report on these tests shows that, despite the fact that the stud assembly of one unit was in an advanced stage of degradation and the load pin was considerably reduced in diameter within the stud assembly, all three coupling links failed at a load in excess of the manufacturer's specified minimum breaking load of some 32,800 kg (72,300 lb). The chain samples also showed signs of corrosion. However, in spite of the corrosion layer being up to 1 mm thick, the interior of the chain was found to be sound.

recovered, suggesting that the alloy pin failed in shear or that the pin worked its way out. The TSB Engineering Laboratory report suggests that the most probable failure scenario was that the load pin could have slipped out of the missing coupling link if there was wastage of the stud assembly due to corrosion.
