MARINE INVESTIGATION REPORT

M97M0094

MAN OVERBOARD

“MACDONALD’S III”

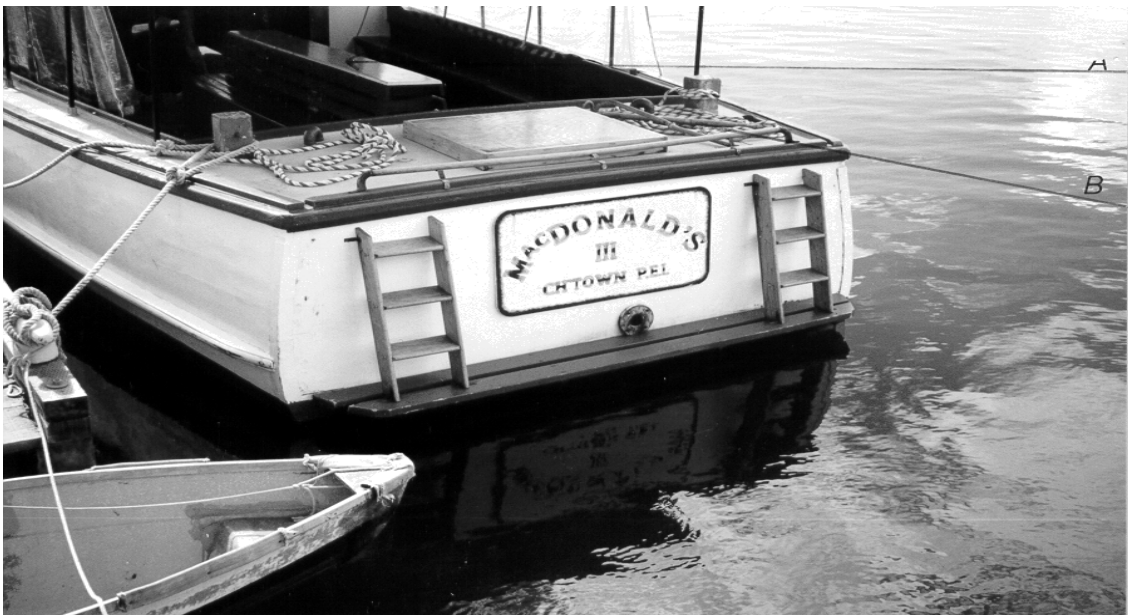
"MACDONALD'S III"

Observers confirmed that the missing man first climbed onto the port side of the after deck and started dancing (described colloquially as "jigging"). Passengers in the vicinity tried to persuade this man to come back down onto the well deck. Instead of returning, he moved over to the starboard quarter, where an anchor and a coil of rope were stowed on the deck. He resumed jigging despite the requests from other passengers to come back to the well deck. He fell overboard shortly thereafter.

The lifejackets were stowed in an unidentified box in the well deck. There were no placards posted indicating the correct method of wearing and securing a lifejacket. There was also no announcement or demonstration made by any members of the crew regarding the safety equipment when the passengers boarded.

- A. Unmarked box containing lifejackets
- B. Area from which man fell overboard
