MARINE INVESTIGATION REPORT

M98W0045

SWAMPING WITH LOSS OF LIVES

“OCEAN THUNDER”

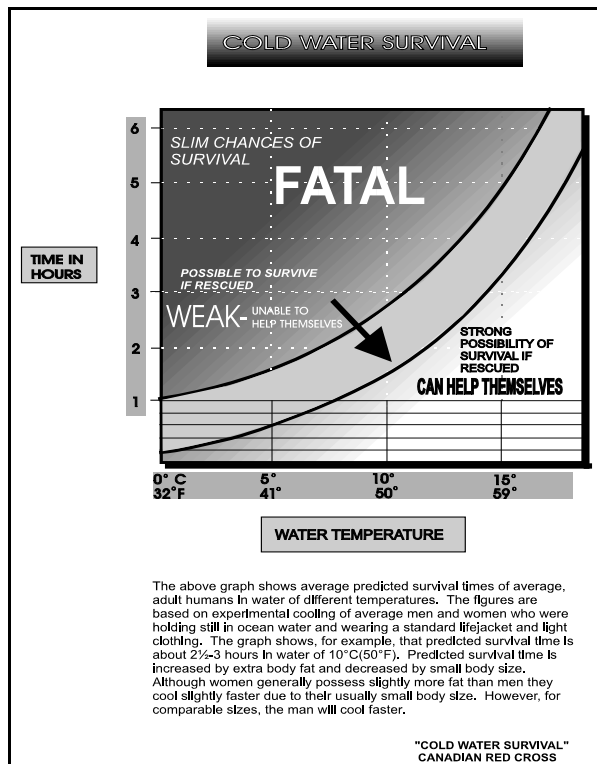
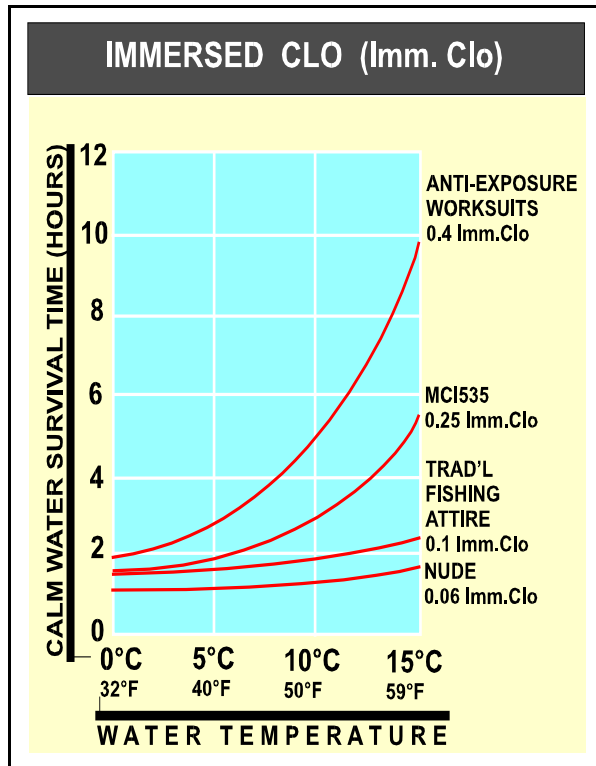
The operator was 1.79 m tall and weighed approximately 97 kg. He was wearing a coverall PFD suit, which was not fully zipped, over seasonal clothing. The passenger who lost his life was 1.86 m tall and weighed about 147 kg. He was a non-swimmer and was wearing a coverall PFD suit which was fully zipped over seasonal clothing.

The donning of the suits protected those on board from the harsh environmental conditions. According to the manufacturer of the suit, the thermal protection afforded by the suit had the potential to increase their survival time between two to four times.
