RAILWAY INVESTIGATION REPORT
R00M0007

COLLISION AND DERAILMENT

VIA RAIL CANADA INC.
PASSENGER TRAIN NO. 14
MILE 65.1, NEWCASTLE SUBDIVISION
MIRAMICHI, NEW BRUNSWICK
30 JANUARY 2000

Report Number R00M0007

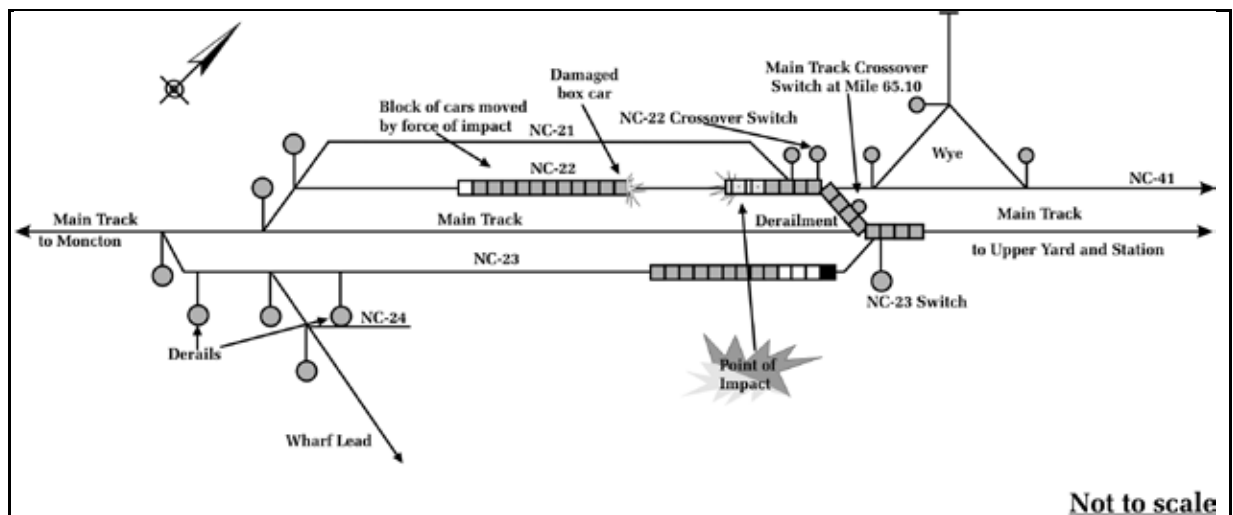
At 1012, the train accelerated and was proceeding at 41 mph, 1 mph higher than the maximum allowable zone speed, as it approached the switch for track NC-23 (a yard track south of the main track) at Mile 65.2 (see Figure 2). The locomotive engineer at the controls recalled that he saw that the main track crossover switch at Mile 65.1 was lined for the reverse position just after the lead locomotive passed the NC-23 switch. The NC-23 switch was 330 feet west of the main track crossover switch.

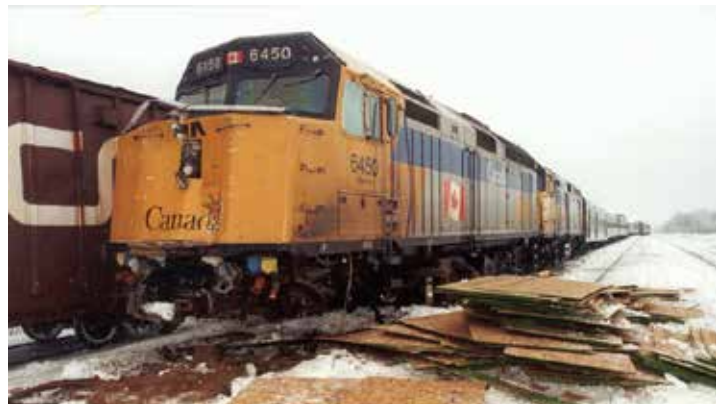
The impact deformed the first loaded box car, forcing the load of fibreboard upward through the roof of the car and littering the roadbed with debris. VIA 14 then moved the cars 560 feet (see Photo 1). As well, the impact lifted the leading VIA locomotive up and off its front truck. The truck stopped and the forward momentum of the locomotive body drove the battery boxes and fuel tanks against the derailed truck, damaging the batteries and rupturing the fuel tanks (see Photo 2). The second locomotive, the baggage car, and six of the following passenger cars also derailed. Diesel fuel and battery acid were spilled. Two crossover switches and 450 feet of track were damaged.

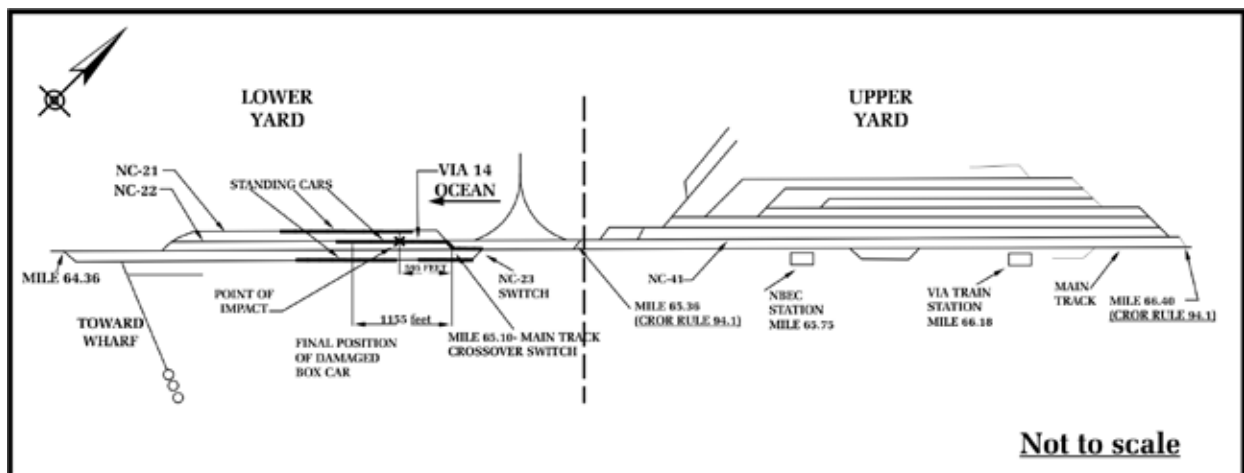
The yard tracks in Miramichi extended from Mile 66.4 to Mile 63.5. There were two separate yards, known as the upper and lower yards (see Figure 3). The two yards were joined together by the main track and by track NC-41 which, when it reached the main track crossover at Mile 65.1, was redesignated track NC-22 in the lower yard. The main track was tangent from Mile 66.4 to Mile 64.0. The track grade was minus 0.8 per cent descending for eastward trains.
