RAILWAY INVESTIGATION REPORT

R01M0061

CROSSING ACCIDENT AND DERAILMENT

MILE 178.67, NAPADOGAN SUBDIVISION

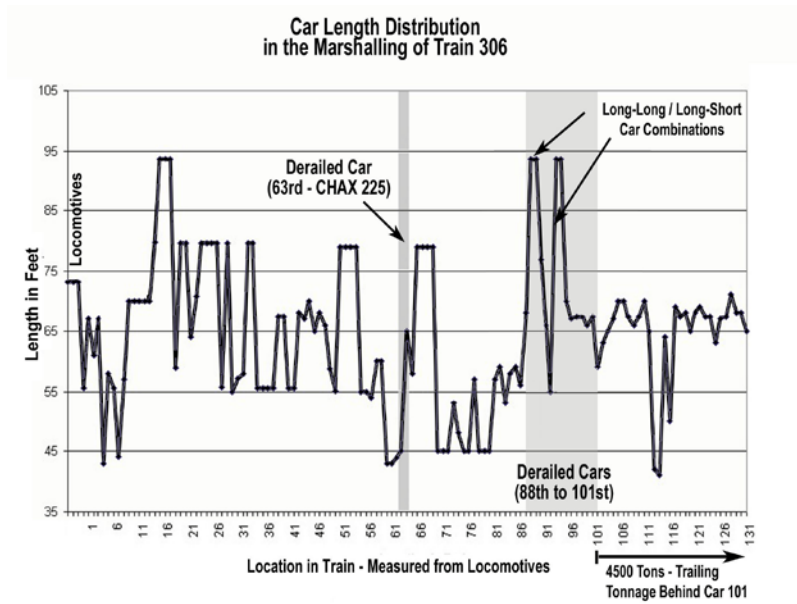
Most of the loaded cars on train 306 were located in the tail-end portion of the train (see Figure 2). There were several long-long and long-short car combinations in the consist (see Figure 3). Ten of the cars were equipped with EOCCDs. Train 306 passed by a wayside information system at Mile 200.5; no defects were noted.
