RAILWAY INVESTIGATION REPORT
R06T0022

MAIN-TRACK DERAILMENT

CANADIAN PACIFIC RAILWAY
FREIGHT TRAIN 230-30
MILE 114.65, MACTIER SUBDIVISION
BUCKSKIN, ONTARIO
31 JANUARY 2006

Report Number R06T0022

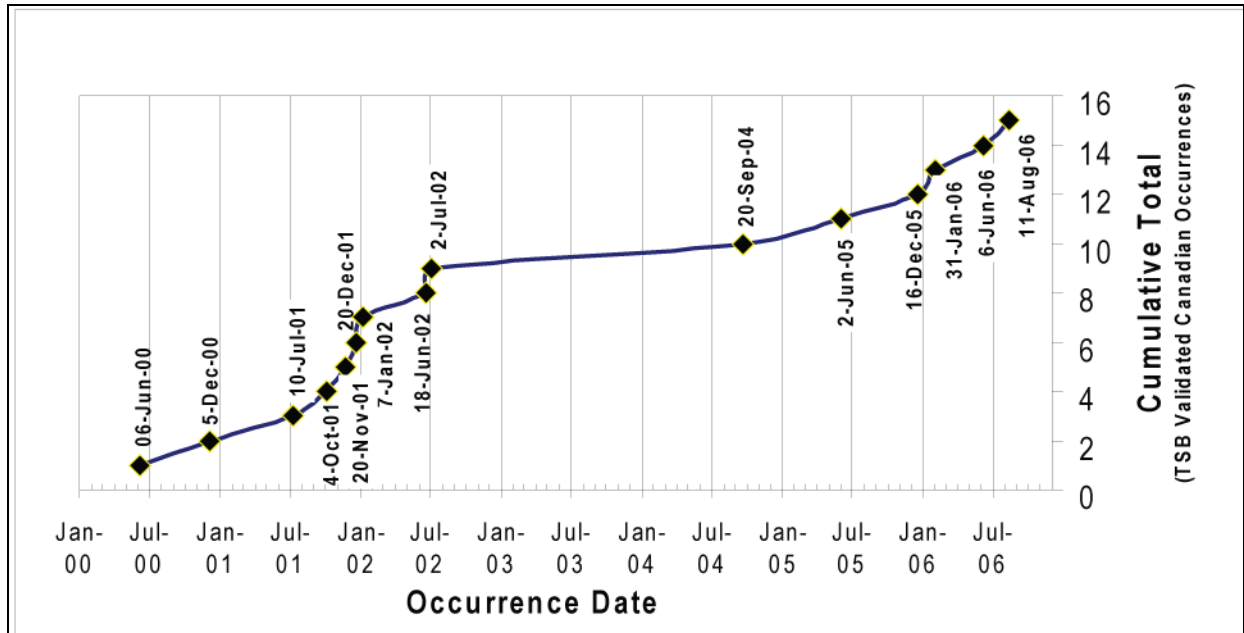
Figure 3. Cumulative main-track derailments in Canada involving loose 36-inch Canadian National Transcona wheel shop wheel sets, by date

From 2000 to date, CN has documented a total of 15 main-track derailments in Canada caused by loose wheels (see Figure 3). A detailed listing of these derailments is presented in Appendix A. In addition, it has documented at least two other loose wheel derailments that occurred outside Canada. CN has reported an additional 48 wheel sets with loose wheels detected by subsequent inspection (see Appendix B). In each of these cases, the wheels were mounted by the CN Transcona wheel shop between April 1998 and February 2001 and became loose.
