RAILWAY INVESTIGATION REPORT
R06V0136

RUNAWAY/DERAILMENT

CANADIAN NATIONAL
FREIGHT TRAIN L-567-51-29
MILE 184.8, LILLOOET SUBDIVISION
NEAR LILLOOET, BRITISH COLUMBIA
29 JUNE 2006

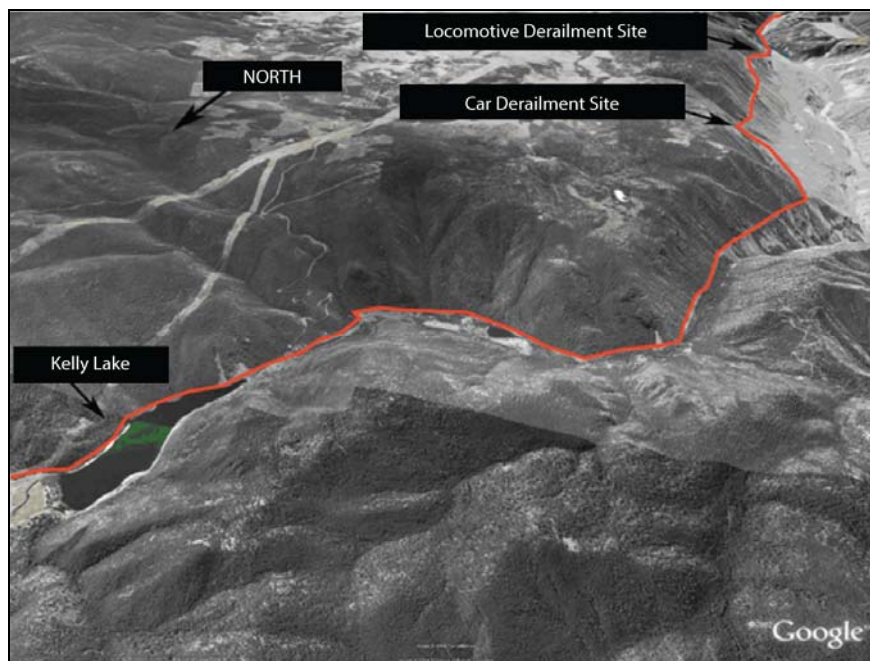
The Lillooet Subdivision extends from Mile 157.6 at Lillooet to Mile 312.9 at Williams Lake, British Columbia. The area in which the accident occurred is rugged, mountainous territory (see Photo 7). The track at this location is built into the side of the Coastal Mountains and follows the Fraser River. From Mile 190.8 to about Mile 167.0, there is a descending grade that varies between 1.5 and 2.85 per cent. The railway considers the controlling grade between Fountain, British Columbia, Mile 165.3, and Kelly Lake to be 2.2 per cent for northward movements.

Photo 7. Lillooet Subdivision from Kelly Lake to the derailment site

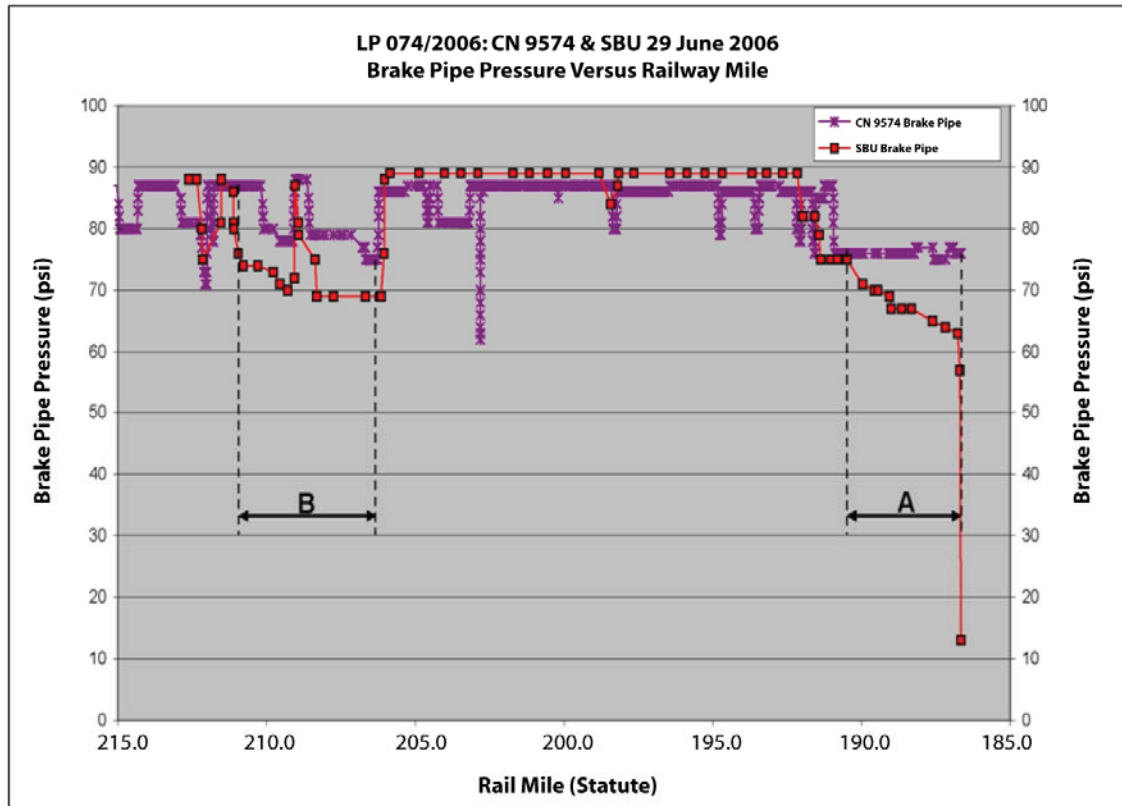
A comparison of the SBU data to the test train LER data disclosed that, although the test train approached the Kelly Lake summit at approximately the same average speed as the occurrence train (20.0 mph near Mile 191.4), and the test train's average speed remained higher than the occurrence train's average speed during the initial phases of the descent, the occurrence train required a much larger sustained service brake application to try to control the speed while descending the exact same grade (refer to Area "A" in Figure 3).

Analysis of data also indicated that the test train and the occurrence train had both been travelling at the same average speed of approximately 29.2 mph near Mile 211.0. Both trains then traversed the same section of track to Mile 206.4, at which point both were once again travelling at the same average speed (approximately 30.7 mph). During the voyage, the occurrence train required a much larger sustained service brake application when compared to the test train, in order to control the speed while descending the exact same grade between Chasm and Clinton (refer to Area "B" in Figure 3).

Figure 3. Comparison of test train locomotive event recorder data to the sense and braking unit data from the occurrence train

The test train crested the summit at Mile 190.8, just past Kelly Lake, with the brake pipe reduced from 87 psi to 76 psi, an 11 psi brake pipe reduction or 44 per cent of its service braking capability, while the accident train crested the grade with the brake pipe reduced from 89 psi to 75 psi, a 14 psi brake pipe reduction or 55 per cent of its service braking capability.

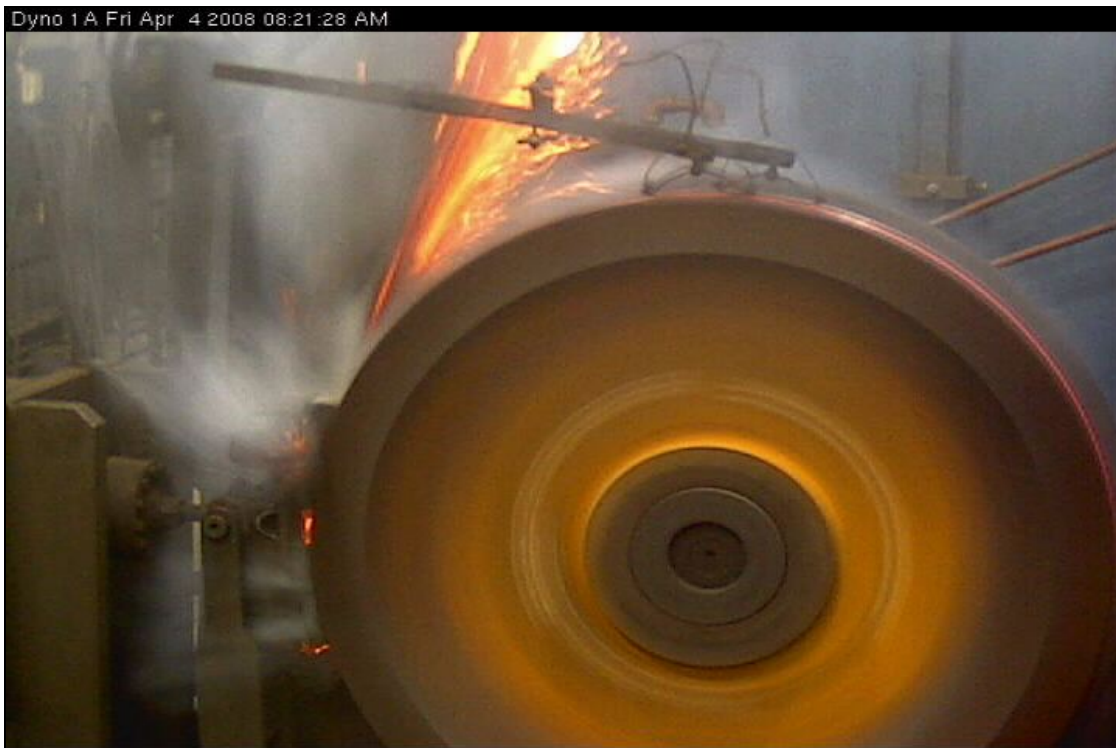
To better substantiate and validate theoretical predictions and BHP calculations, dynamometer testing was performed at the brake shoe manufacturer's facility (TSB Engineering Laboratory Report LP 074/2006). During the tests, a locomotive wheel was fixed at the end of a shaft and a brake shoe assembly was mounted adjacent to it (see Photo 9). When the wheel was spun, the test brake shoe was applied to the wheel tread to simulate the actual braking of a locomotive. Sensors calculated and recorded parameters such as distance travelled, velocity, wheel tread

Photo 9. Dynamometer testing

This work was carried out to further test the hypothesis that brake shoe friction fade occurred in this accident. Dynamometer tests were run simulating the descent of the grade with the locomotive only, with the locomotive and car, with the locomotive and car with inoperative brakes on the car and, finally, with the car only simulating normal brake applications followed by an emergency brake application. In addition, the same input data were used to see if theoretical heat transfer predictions might correlate with the residual stress levels found in the overheated locomotive wheels (that is, correlation with saw-cut test results [see Section 1.11.5]).

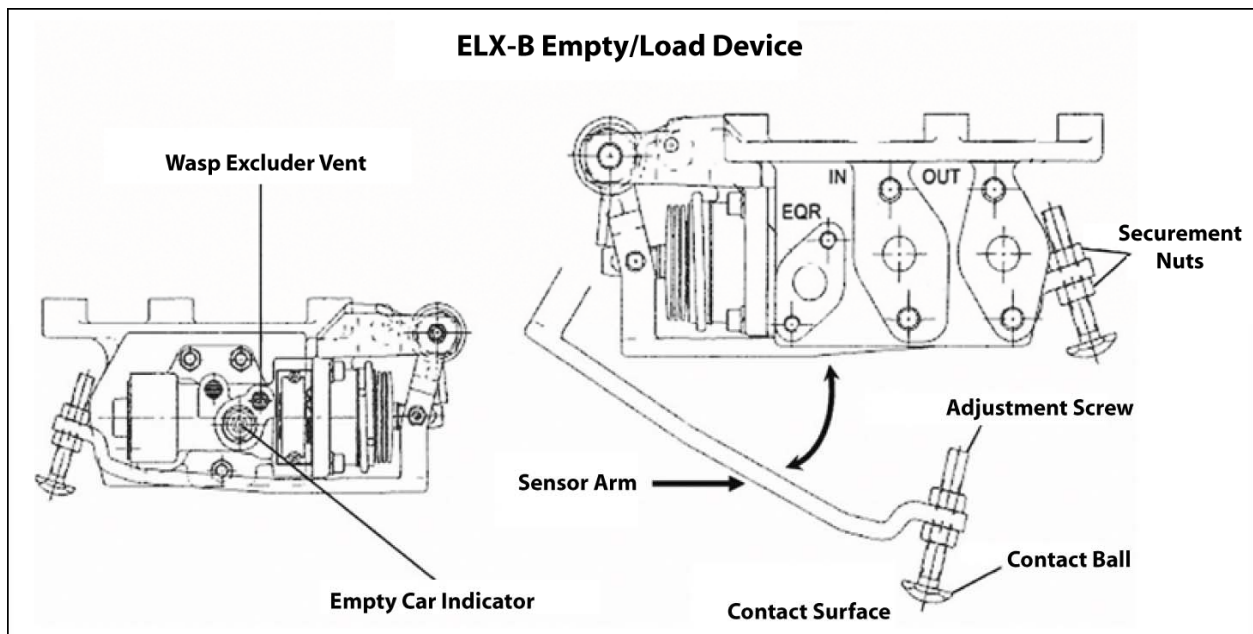
The ELX-B 60 per cent empty/load device that was on the occurrence car was secured to the underframe of the car body, and its sensor arm swings down when an air brake application is made. This causes the sensor arm to contact the sensor plate, which is welded to the top of the truck side frame (see Figure 4). The sensor plate provides a smooth flat surface upon which the foot of the empty/load device would contact when the train was in motion (that is, the empty/load device is mounted on the car body but the sensing arm on it contacts the truck that rotates independently). Bench testing of the empty/load device from the occurrence car showed that it operated properly. Further inspection revealed that it had retained its original factory settings.

Figure 4. Schematic of ELX-B empty/load device (Source: Wabtec Corporation Instructional Leaflet 5229)

During examination of the accident car and several other cars (at Joffre, Quebec), as well as subsequent air brake testing of similar centre beam cars (at Winnipeg and Prince George), TSB personnel noted that many of the cars were missing the sensor plate (see Photo 13). Of the nine cars that the TSB examined, five had missing sensor plates: the accident car, the car examined at Winnipeg, one at Prince George, and two at Joffre. Of the four remaining cars, one had a sensor plate that was replaced in the field. It was not as per the original manufacturer in size and shape.
