**RAILWAY INVESTIGATION REPORT  
R10T0020**

**NON-MAINTRACK TRAIN DERAILMENT**

**CANADIAN NATIONAL RAILWAY  
YARD SWITCHING MOVEMENT  
MILE 0.0, HALTON SUBDIVISION  
MACMILLAN YARD, TORONTO (ONTARIO)  
09 FEBRUARY 2010**

Report Number R10T0020

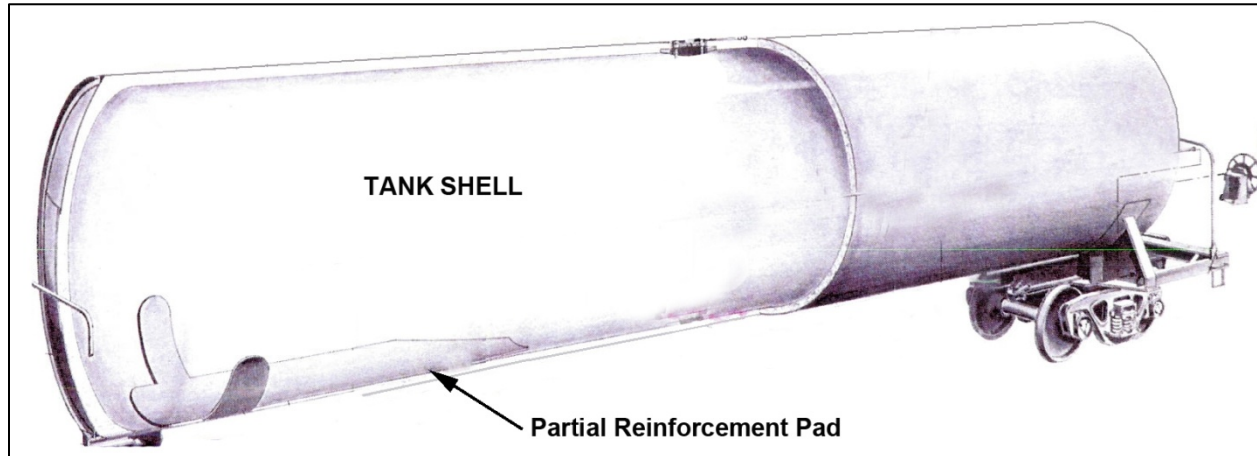
**Figure 4.** Partial stub sill re-pad

Tank car reinforcement pads (re-pads) provide localized reinforcement and skid protection for the shell as well as shear protection for appurtenances welded to them. This design feature is such that, in the event of a derailment, exposed appurtenances are meant to tear away from the re-pads and leave the tank shell intact. Each tank car is equipped with either:

- Continuous re-pads that are welded to the bottom and extend the entire length of the tank shell. Stub sills and various appurtenances are welded to the continuous re-pads; or
- Partial stub sill re-pads, otherwise known as non-continuous re-pads, to which the stub sills are welded (see Figure 4).
