**RAILWAY INVESTIGATION REPORT  
R13T0122**

**MAIN-TRACK DERAILMENT**

**CANADIAN PACIFIC RAILWAY  
FREIGHT TRAIN 119-01  
MILE 112.70, PARRY SOUND SUBDIVISION  
WANUP, ONTARIO  
02 JUNE 2013**

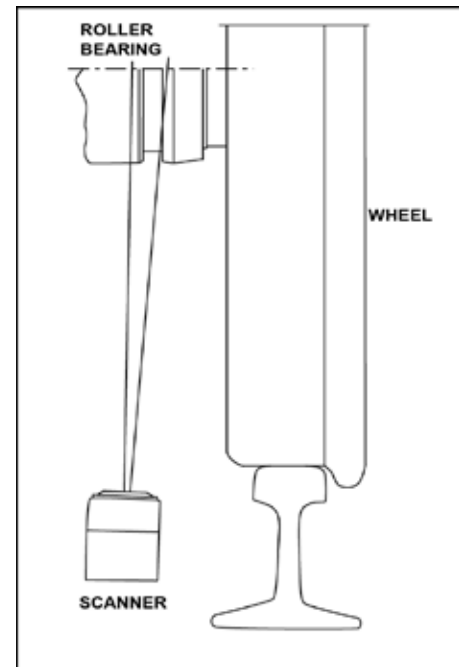
Figure 3. Hot box detector scanner pattern

Each WIS usually includes an HBD, typically spaced 10 to 30 miles apart, a hot wheel detector, and often a dragging equipment detector. The HBD scans each bearing for heat as the train passes over an infrared sensor (Figure 3). The scanner infrared measures and records the bearing temperature. Because there are no regulatory requirements for HBDs, each railway establishes and maintains its own system and alarm thresholds for overheated roller bearings.
