RAILWAY INVESTIGATION REPORT R15H0013

Main-track train derailment

Canadian National Railway Company
Freight train U70451-10
Mile 111.7, Ruel Subdivision
Gladwick, Ontario
14 February 2015

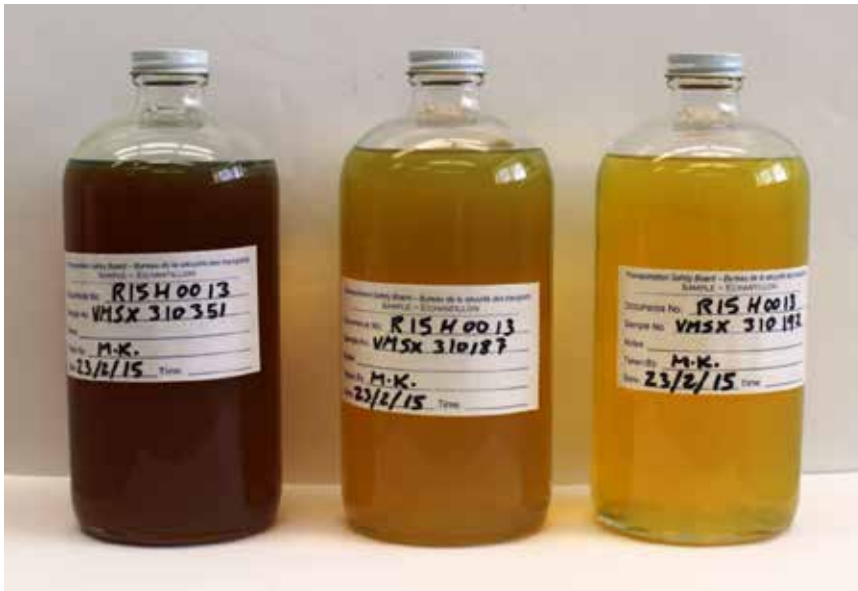
Product samples (Photo 3) were taken from 3 representative non-derailed tank cars.

Photo 3. Oil samples taken from tank cars VMSX 310351, VMSX 310187, and VMSX 310192
