## **RAIL TRANSPORTATION SAFETY INVESTIGATION REPORT R18E0007**

### **UNCONTROLLED MOVEMENT OF ROLLING STOCK**

Canadian National Railway Company  
Freight train L76951-10  
Mile 0.5, Luscar Industrial Spur  
Leyland, Alberta  
10 January 2018

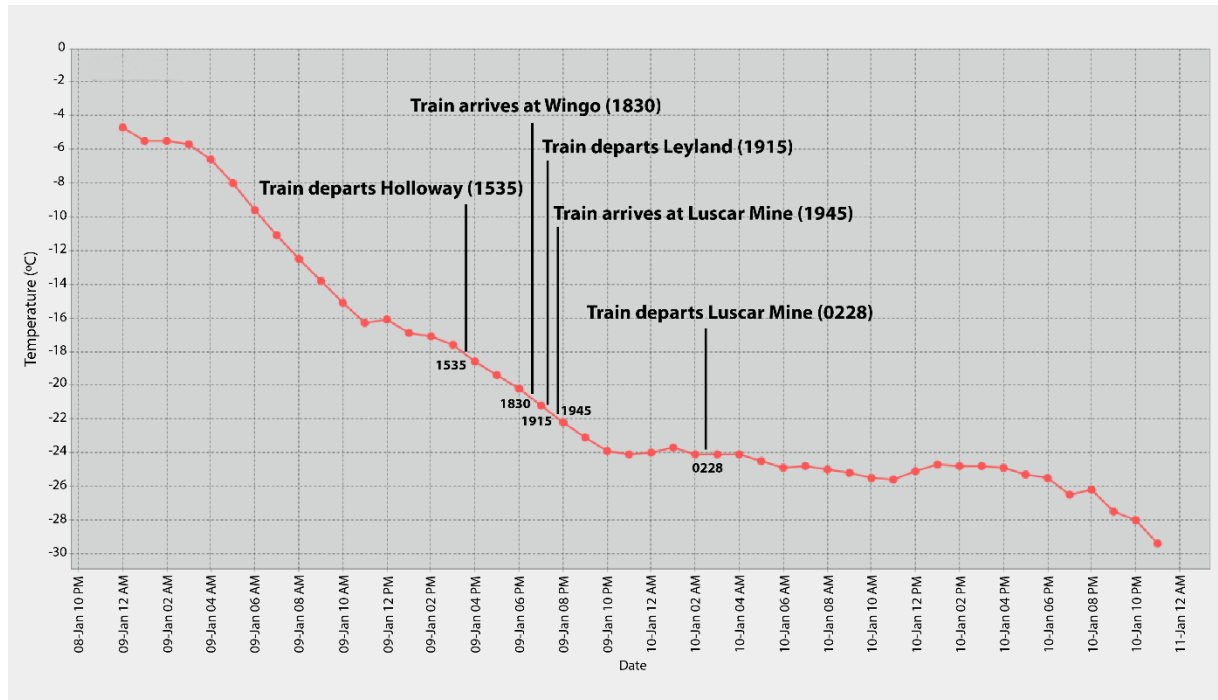
Figure 5. Hourly temperatures at Luscar (Source: Alberta Climate Information Service, with TSB annotations)

On 09 January 2018, the day before the occurrence, the temperature in the region began to steadily decrease, starting at about 0300 (Figure 5). The ambient temperature at the beginning of the day was between  $-4^{\circ}\text{C}$  and  $-6^{\circ}\text{C}$ . At 0228 on 10 January 2018, the temperature had dropped to  $-24^{\circ}\text{C}$ . The ambient temperature at the time of key events is depicted in Figure 5.

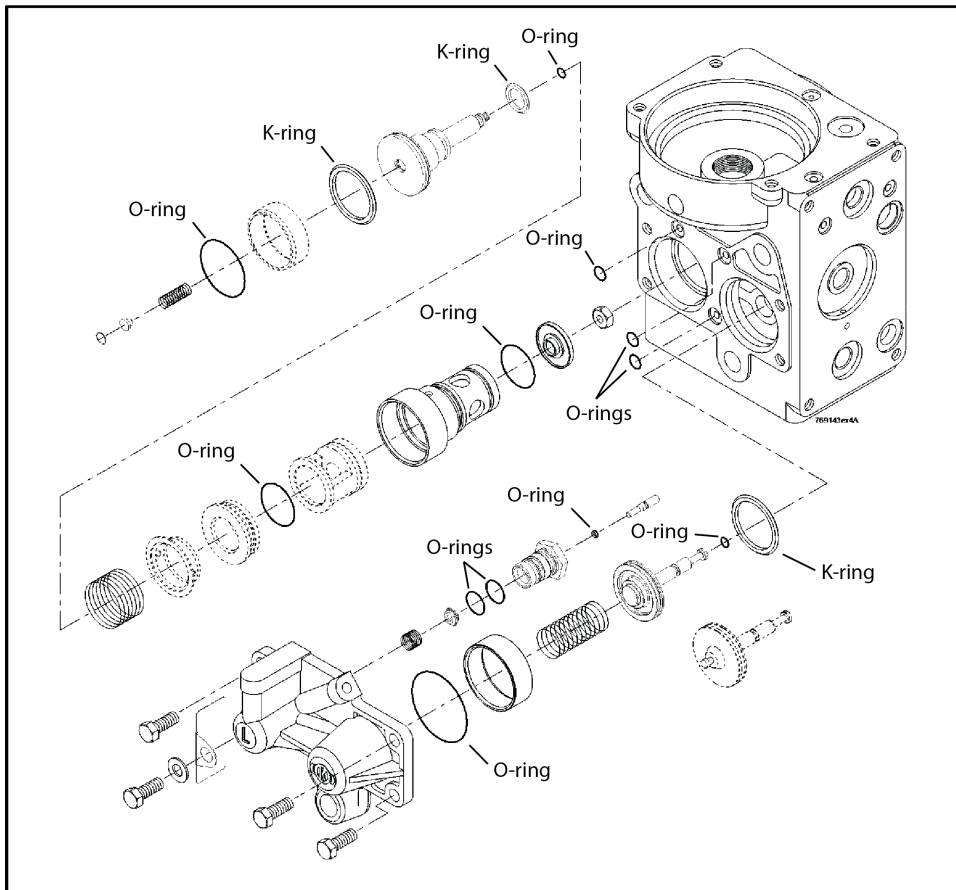
Figure 9. DB-20 emergency portion (Source: NYAB, with TSB annotations)

For the DB-20 emergency portions (Figure 9), the NYAB tests established that the failure mechanism was not the same as that for the service portions. Instead, the failure of the emergency portions was related to deformed K-rings inside the vent valve, which resulted in excessive leakage during extreme cold temperatures and thus resulted in the failure to propagate the emergency brake application command. The setting and deformation of the K-ring rubber had likely occurred when the leased cars were in storage for an extended period before being delivered to CN. Because of these permanent deformations, the intended performance of the K-rings, particularly during cold temperatures, was negatively affected.

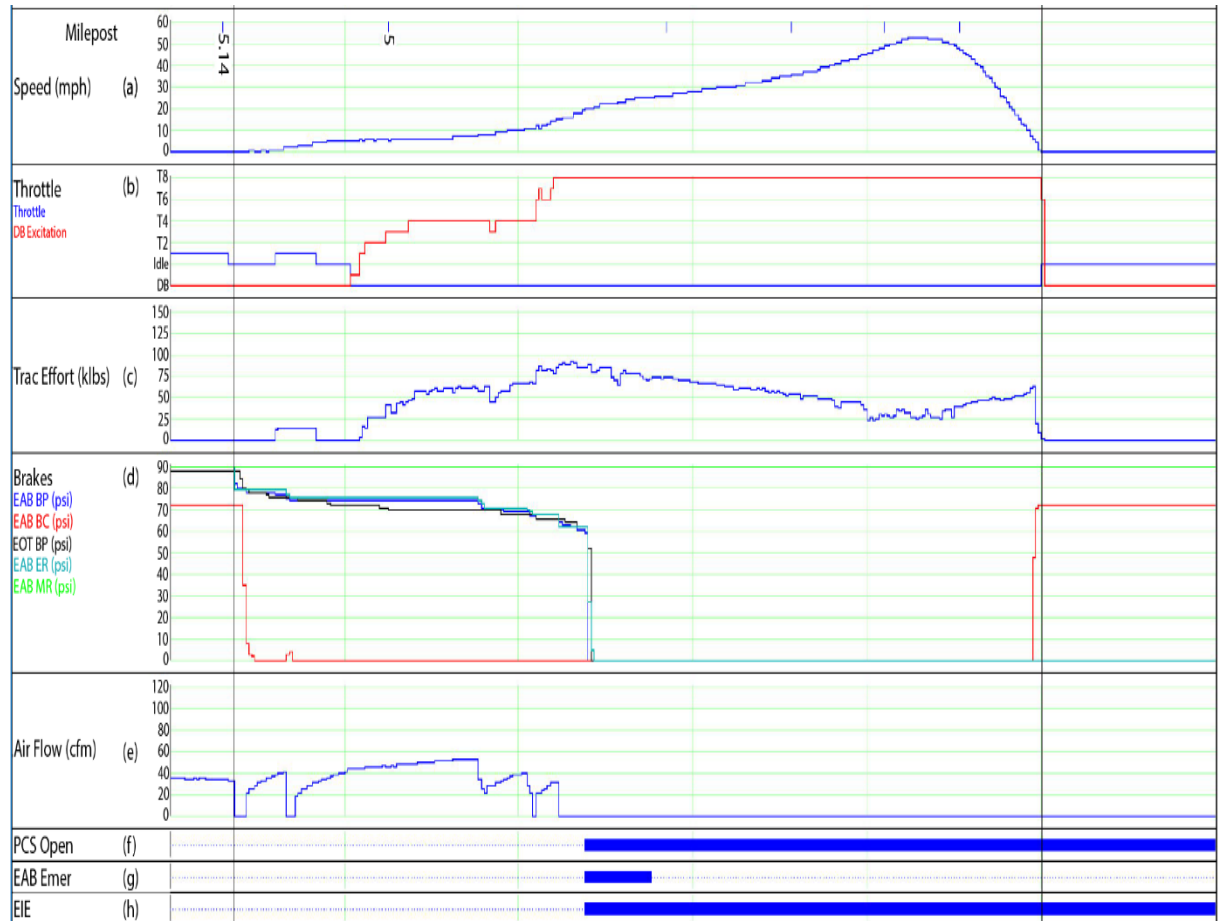
Figure B1. Graphical summary of locomotive event recorder data from locomotive CN 2888 (Source: TSB)

**Row (a), Speed**, depicts the acceleration of the train as it descended the mountain grade, followed by the deceleration of the train as it travelled over the ascending grade at the bottom of the hill. A maximum speed of 53 mph was reached.

**Row (b), Throttle / DB Excitation**, depicts the initial activation between notch 1 and idle as the train began to move. At the transition into DB mode, the coloured line changes to red. DB was increased to maximum, position 8, where it remained until the train came to a stop.
