RAIL TRANSPORTATION SAFETY INVESTIGATION REPORT R18V0127

CROSSING ACCIDENT

Canadian National Railway Company
Freight train Q10521-21
Mile 71.13, Yale Subdivision
Chilliwack, British Columbia
26 May 2018

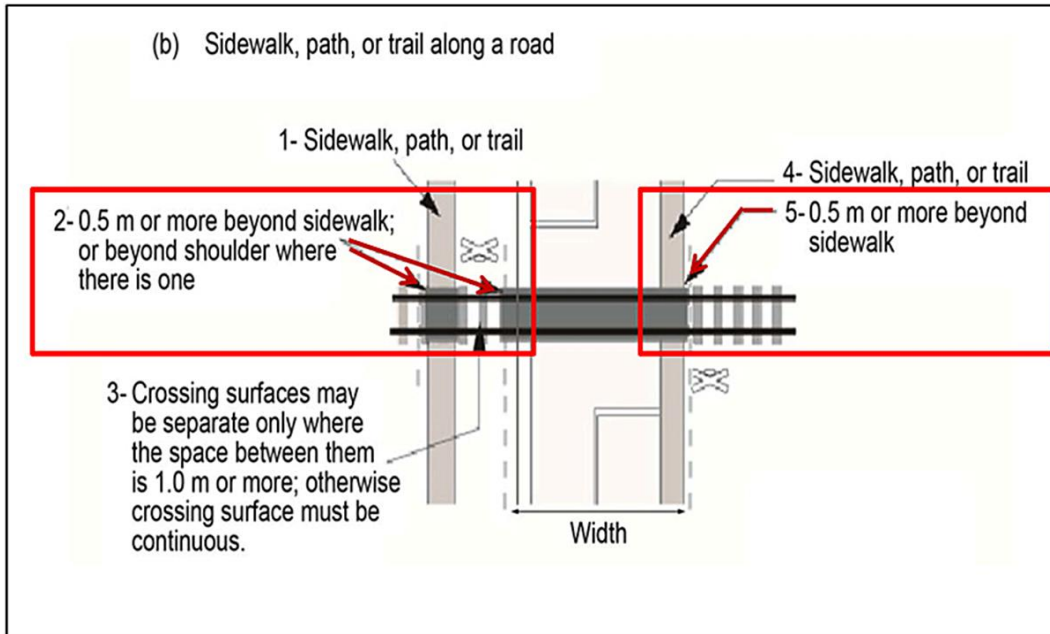
Figure 4. Requirement for crossing surface to extend 0.5 m beyond width of sidewalks and roadways (Source: Transport Canada, *Grade Crossings Standards* (July 2014), Part C, Figure 5-1(b), with TSB annotations)

Part C, Figure 5-1(b), of the GCS indicates that the sidewalk crossing surface should extend at least 0.5 m past the sidewalk (Figure 4). The crossing was compliant with the GCS at the

time of the occurrence, even though it was not required to be compliant until November 2021.
