RAIL TRANSPORTATION SAFETY INVESTIGATION REPORT R19M0018

MAIN-TRACK TRAIN DERAILMENT

VIA Rail Canada Inc.

Mile 15.27, Canadian National Railway Company Newcastle Subdivision

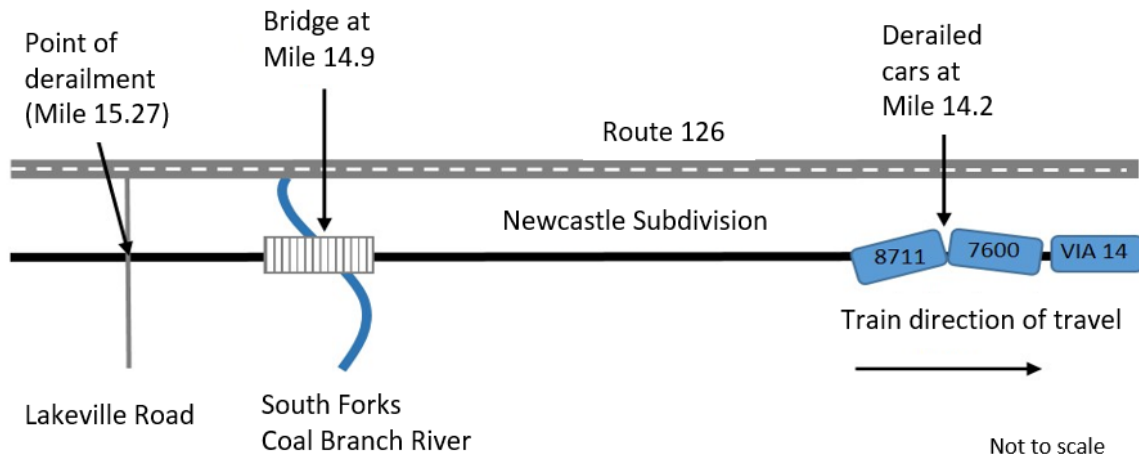
Figure 2. Diagram of the occurrence site (Source: TSB)

Upon inspection, the operating crew determined that the last 2 passenger cars had derailed upright and remained coupled to the train (Figure 3). There had been no train-initiated or occupant-initiated emergency brake application.

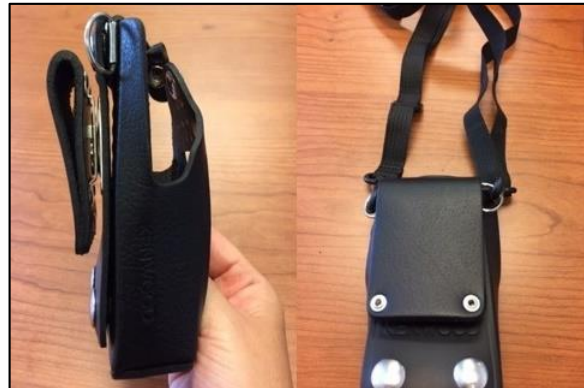
Figure 10. Portable radio holsters/carriers available to OTS personnel (Source: VIA Rail Canada Inc.)

VIA also makes available to OTS employees different types of radio holsters and carriers (Figure 10). These accessories, used at the discretion of individual VIA employees, protect the radios from external shocks and help secure the radio to the employees.

In this occurrence, the OTS employee located in the 14th car had his portable radio clipped to his belt using the integrated plastic belt clip. The car's derailment created significant dynamic forces, which caused the radio to unclip from the employee's belt, fly out of reach, and lose its battery. This left the employee with only the cellular telephone and no means of immediately communicating with the operating crew.
