Rail Transportation Safety Investigation Report R20W0031

MAIN-TRACK TRAIN DERAILMENT

Canadian National Railway Company
Train X35041-18
Mile 108.25, Fort Frances Subdivision
Emo, Ontario
18 February 2020

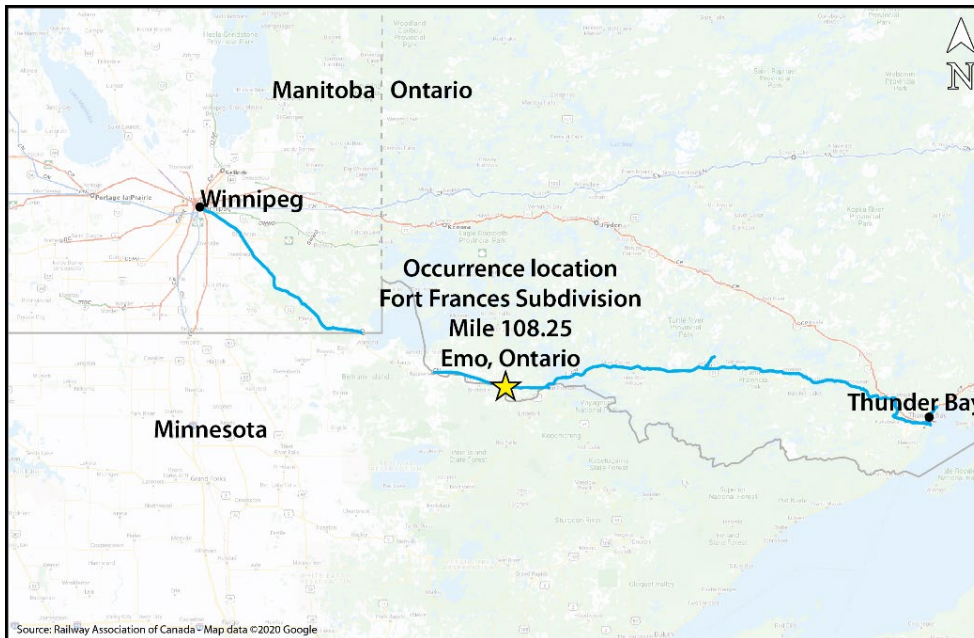
Figure 1. Occurrence location (Source: Railway Association of Canada, Canadian Railway Atlas, with TSB annotations)

At 2036, while proceeding at 44 mph,⁶ the train was negotiating an approximately 4° left-hand curve (in the direction of travel) as it traversed the Ontario provincial highway 602 public automated crossing (Mile 108.22) when a train-initiated emergency air brake application occurred near the township of Emo, Ontario (Figure 1).
