RAIL TRANSPORTATION SAFETY INVESTIGATION REPORT R22D0106

NON-MAIN-TRACK DERAILMENT

Canadian National Railway Company
Train M32621-11
Mile QM 192.1, CSX Transportation Montreal Subdivision
Near Huntingdon, Quebec
11 December 2022

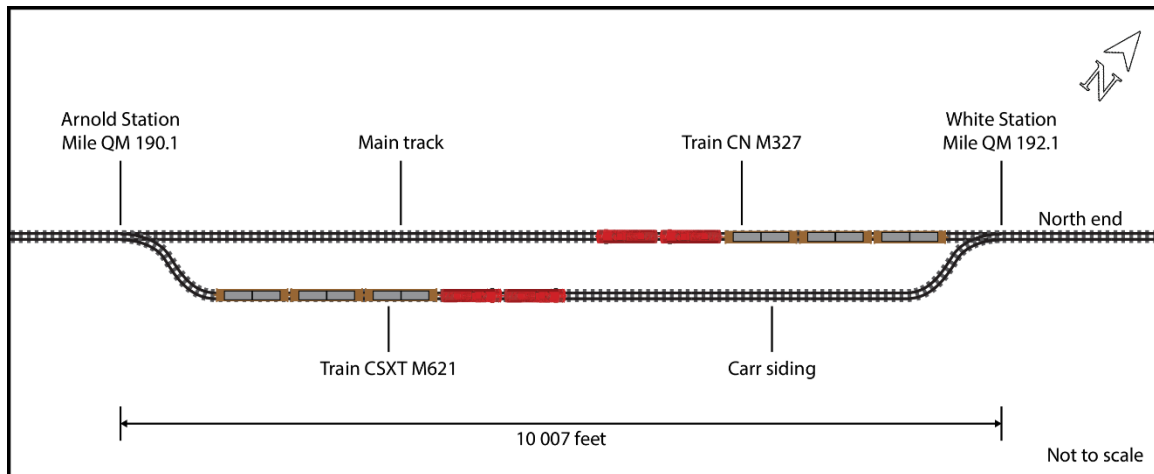
Figure 2. Position of the trains at the interchange point (Source: TSB)

Earlier that day, at about 1500, CN train M327 (CN M327), operated by a CN crew, had left Taschereau Yard in Montréal, Quebec, bound for the interchange point. Approaching the Carr siding, the crew stopped CN M327 on the main track, with the head-end locomotives opposite those of CSXT M621 (Figure 2). This method facilitates the transfer of train crews while keeping the northern end of the siding (White Station) clear as much as possible.

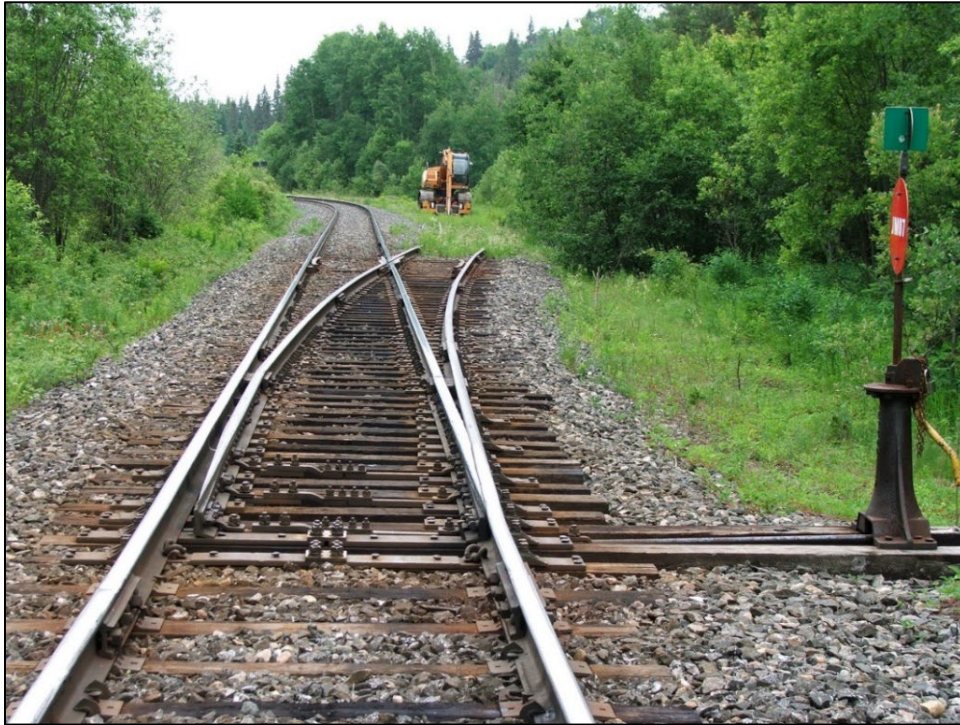
Figure 5. Typical hand-operated switch in an occupancy control system (Source: TSB)

In Canada, the majority of OCS main-track switches are hand-operated (Figure 5).¹² Operating procedures for these switches are detailed in Rule 104 of the *Canadian Rail Operating Rules* (CROR). Rule 104(q) states the following:

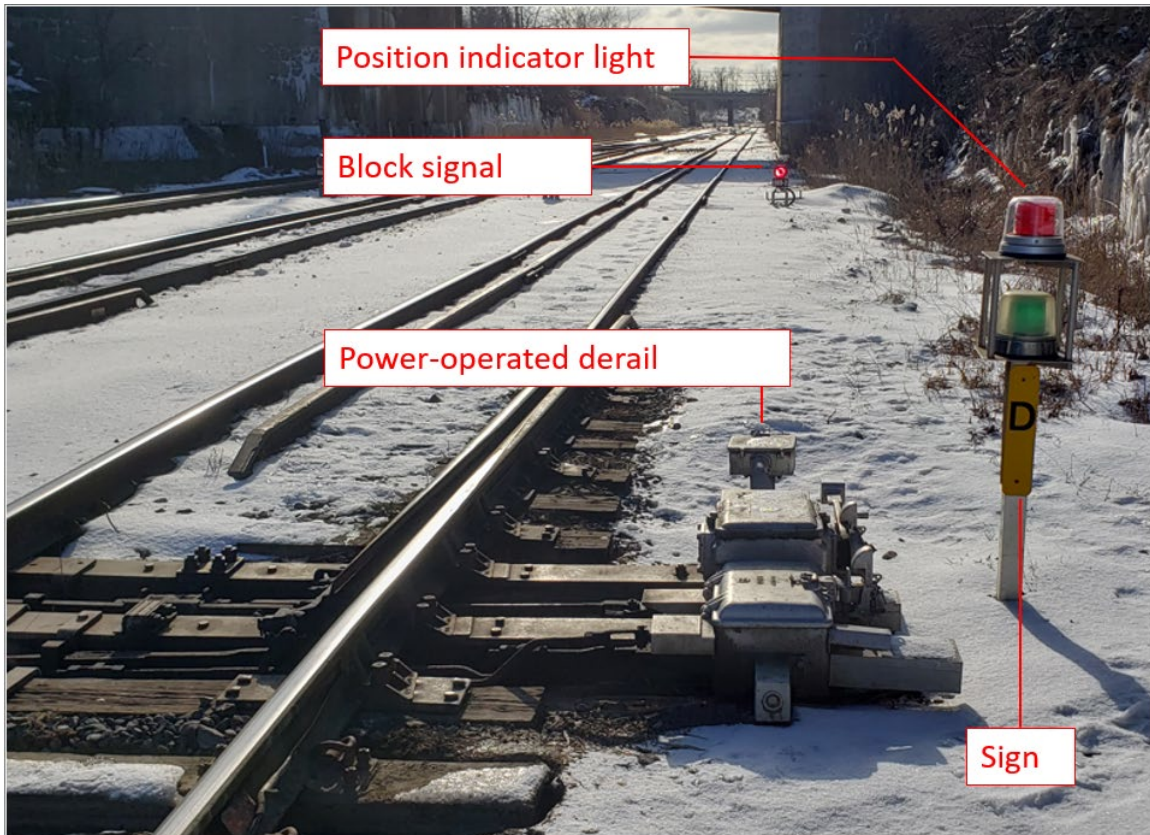
Figure 8. Example of a power-operated derail equipped with a position indicator light and a sign (Source: TSB)

Most radio-controlled, power-assisted derails linked to railway signals in Canada are equipped with a separate position indicator light and a reflectorized sign (Figure 8).
