Transportation  
Safety Board  
of Canada

**TRANSPORTATION SAFETY BOARD OF CANADA**  
**ANNUAL REPORT TO PARLIAMENT**  
**2020–21**

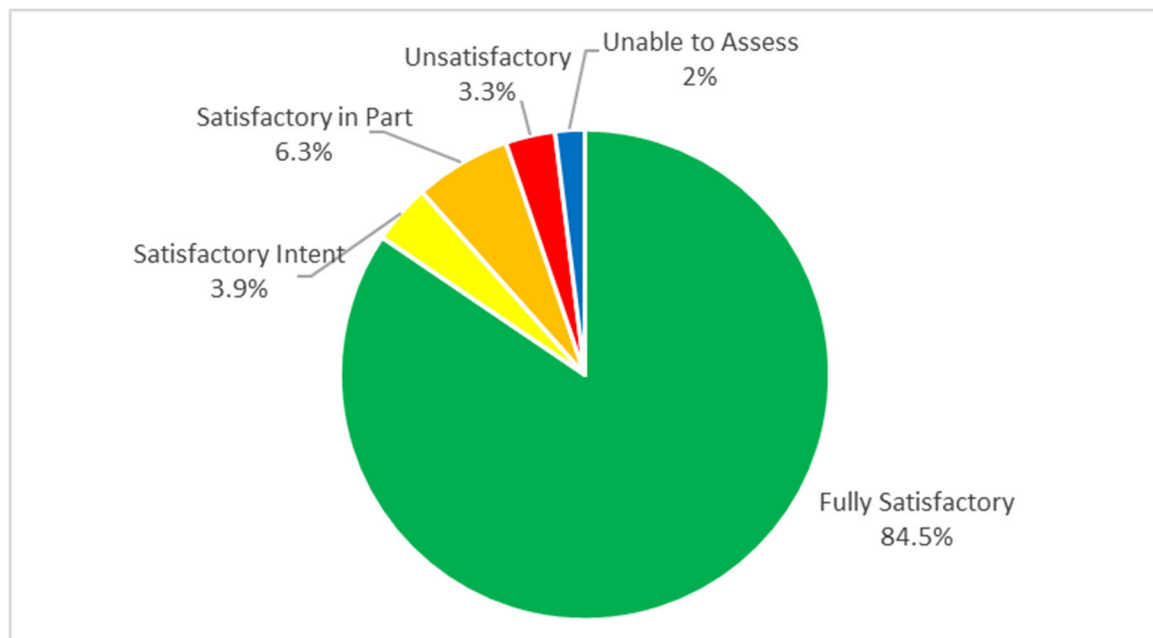
Since 1990, the Board has made 612 recommendations. By the end of 2020–21, it had given 84.5% of the responses to these recommendations the highest rating of Fully Satisfactory (up from 83% at the end of 2019–20). This means that stakeholders, including Transport Canada, have acted to substantially reduce the safety deficiencies the Board identified.

Figure 2. Board assessments of responses to recommendations, 29 March 1990 to 31 March 2021

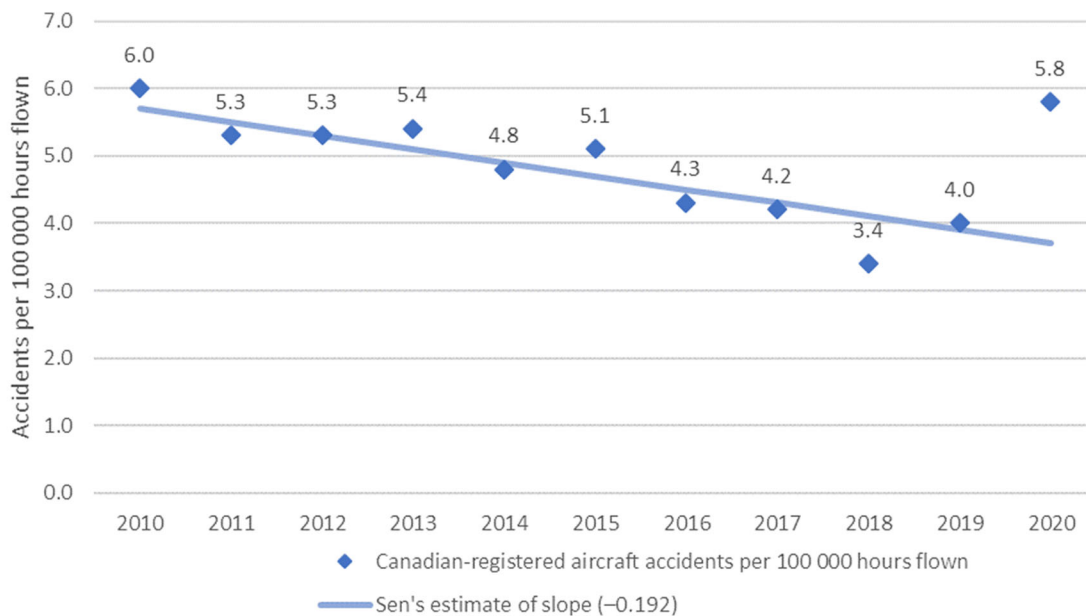
The overall air transportation accident rate of 5.8 per 100 000 hours flown in 2020 is based on 149 accidents in Canada and abroad involving Canadian-registered airplanes and helicopters (ultralights, gyroplanes, gliders and Unmanned Air Vehicles are excluded) and the estimated 2.55 million hours flown by Canadian-registered aircraft. This rate is above the 2019 rate of 4.0 and 24% above the average rate of 4.7 over the previous 10 years. While the number of hours flown decreased by almost half in 2020 compared to 2019, the number of reported accidents decreased by only around 25%. Taken together, this explains why the accident rate increased in 2020.

Figure 4. Accident rate for Canadian-registered airplanes and helicopters, 2010 to 2020

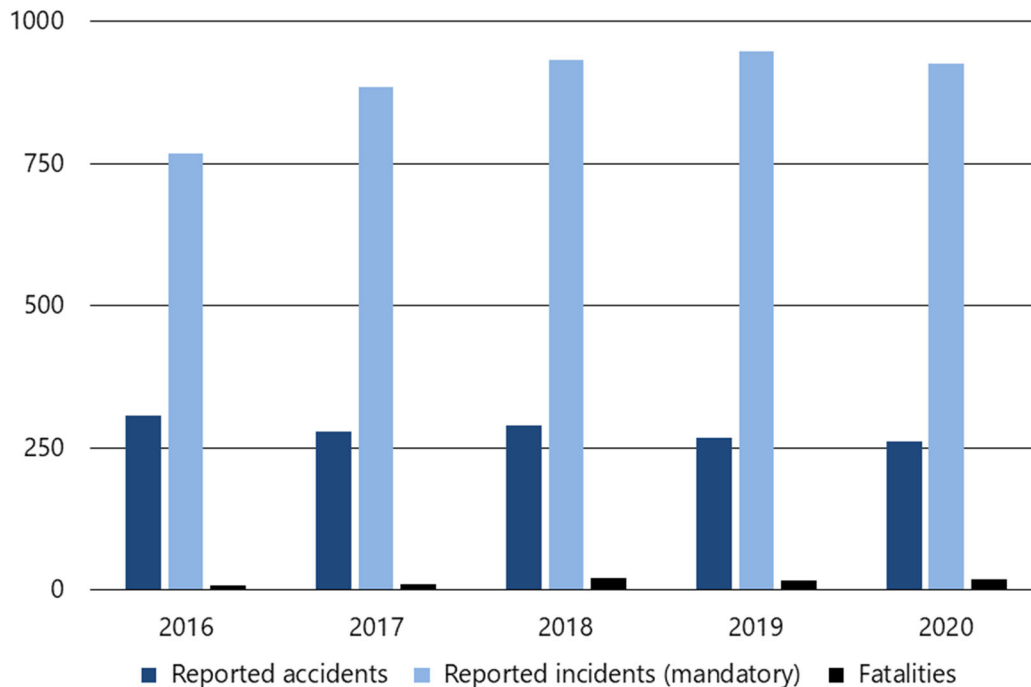
Figure 5. Marine transportation accidents, incidents and fatalities, 2016 to 2020

The total of 262 marine transportation accidents represents a slight decrease from the 267 accidents in 2019 and is lower than the 10-year average of 289. In 2020, 84% of accidents were shipping accidents (when a ship, for example, sinks, founders or capsizes), compared to 82% on average over the previous 10 years. The remaining 16% of accidents in 2020 were accidents aboard ship (when a person is killed or seriously injured when, for example, boarding a ship or by falling overboard), compared to the 10-year annual average of 18%.

The 18 marine transportation fatalities exceed the 2019 total of 17 and the 10-year average of 15.4. Of the 18 fatalities, 12 involved shipping accidents, in contrast to 2019 when most fatalities (13 of 17) occurred aboard ship. Over the previous 10 years, fatalities have been fairly evenly divided between shipping accidents and accidents aboard ship.

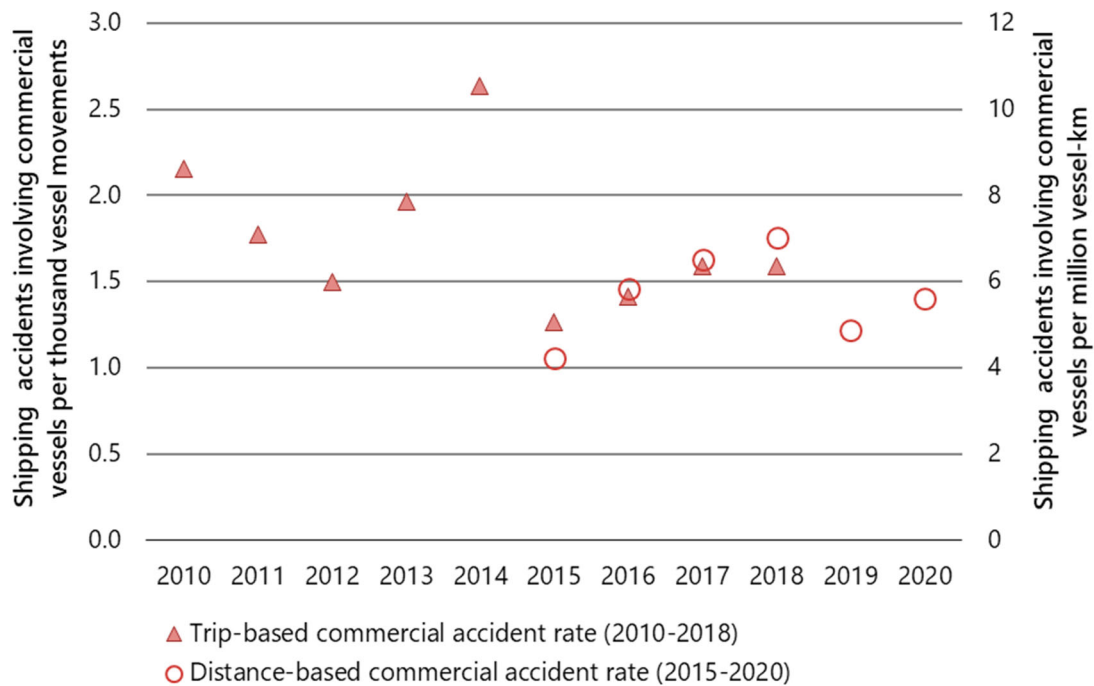
According to Transport Canada, 2020 marine activity (commercial vessel-kilometres) for Canadian commercial non-fishing vessels with a gross tonnage of over 15 (excluding passenger vessels and cruise ships) was 17% above the 2015-to-2019 average. The 2020 accident rate was 5.6 accidents per million commercial vessel-kilometres, slightly lower than the 2015-to-2019 average of 5.7. (Transport Canada now provides a comprehensive distance-based metric of commercial marine activity in Canadian waters beginning from 2015. However, a six-year series is too short to test for meaningful trends, and vessel movements are no longer captured.)

Figure 6. Shipping accident rate, Canadian commercial non-fishing vessels, 2010 to 2020

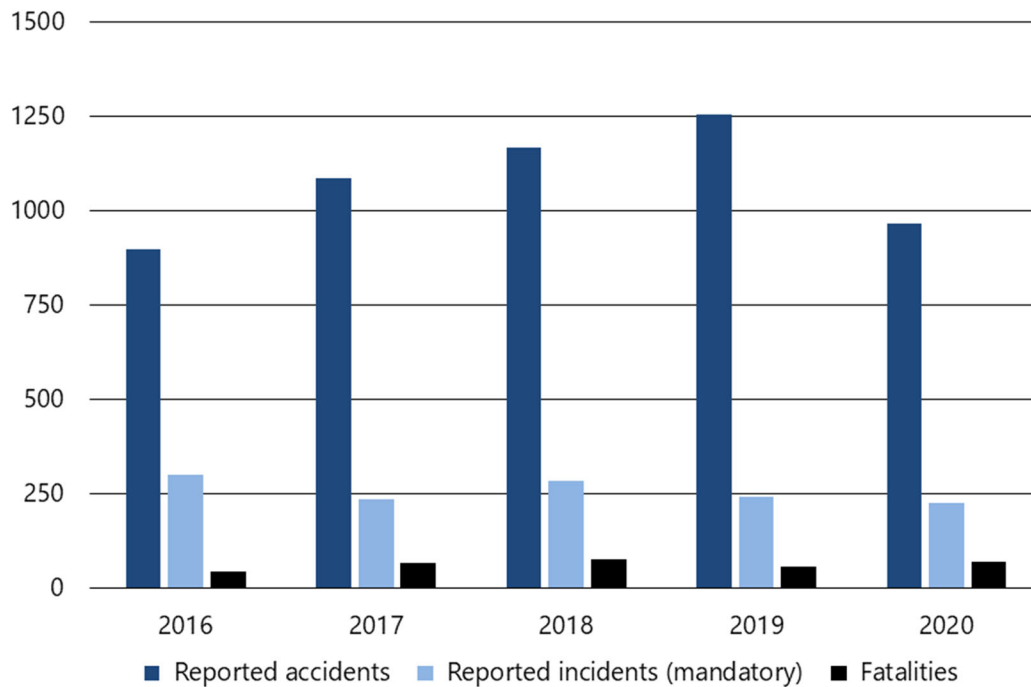
Figure 9. Rail transportation accidents, incidents and fatalities, 2016 to 2020

The 965 accidents represent a 23% decrease from 2019 and an 11% decrease from the 10-year average of 1083.

The 59 rail transportation-related fatalities reported in 2020 are 13 fewer than in the previous year and below the 10-year average of 73. Among the fatalities, 39 involved trespassers, compared to 38 in 2019 and the 10-year average of 42.

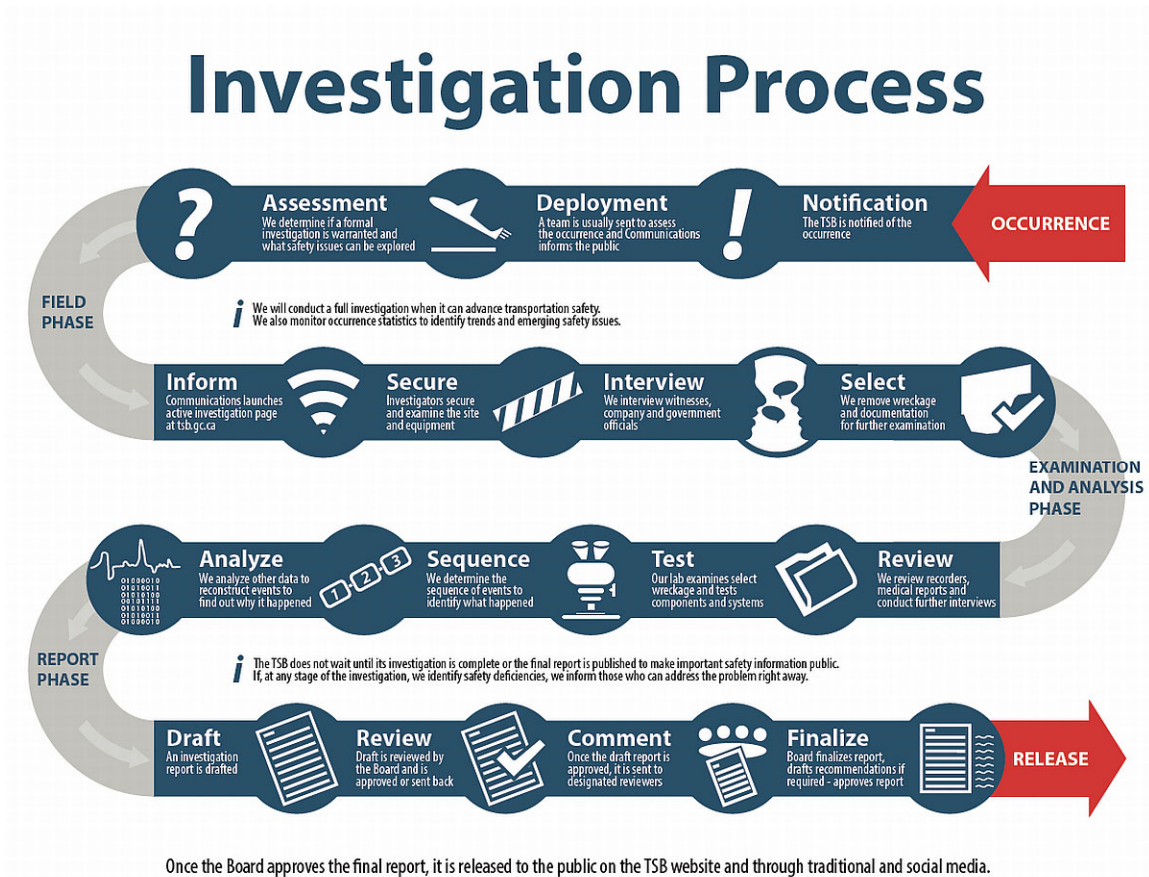
In the report phase, investigators draft a report on the investigation, which then goes through a review and approval process, prior to public release.

Figure 11. The TSB investigation process from occurrence to report
