AVIATION INVESTIGATION REPORT

A00H0002

LOSS OF SEPARATION

NAV CANADA  
GANDER AREA CONTROL CENTRE  
SYDNEY, NOVA SCOTIA 95 NM N  
11 APRIL 2000

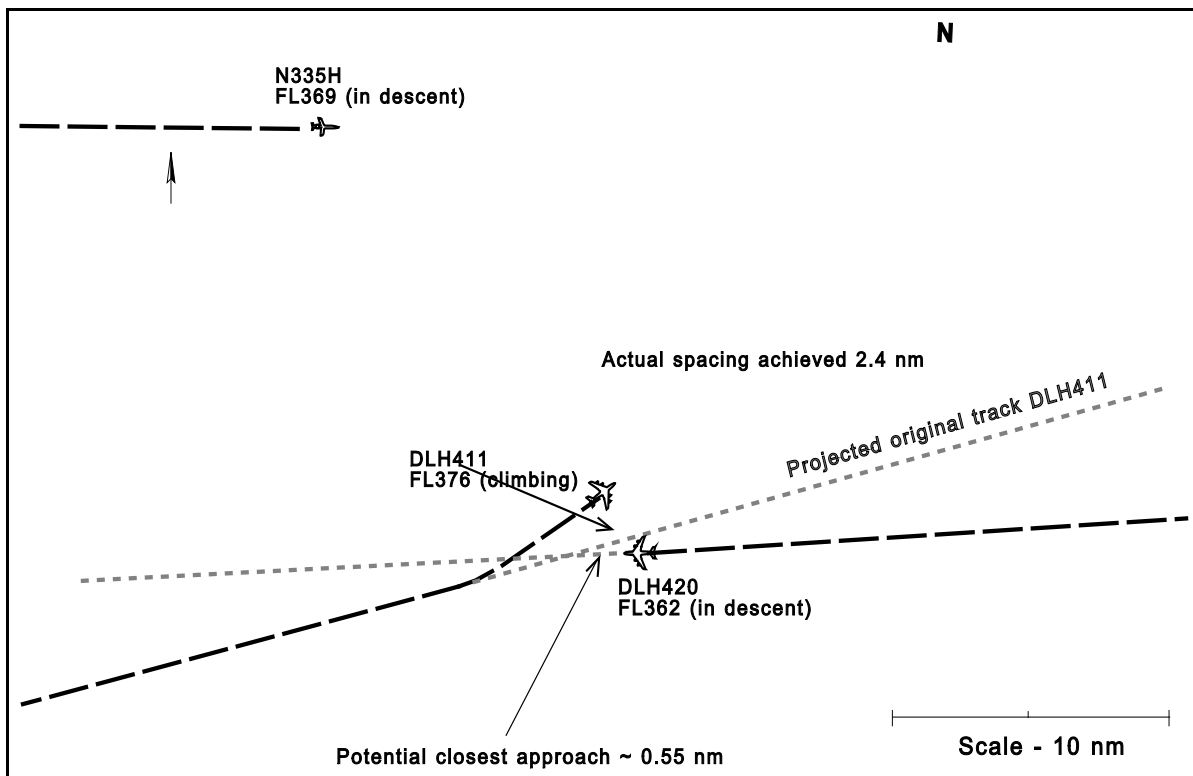
At the time of the warning from DLH411 indicating that the two Lufthansa aircraft were 20 miles apart, they were closing at 16.5 nm per minute. By the time the second controller had issued a descent clearance to DLH420, and the pilot reported leaving FL370 at 1851:11, the aircraft were 13.6 nm apart. Recorded radar

information indicates that DLH411 began a turn when the two aircraft were 11 nm apart, and DLH420 showed a descent out of FL370 when they were 8.5 nm apart. The 20-degree left turn for DLH411 was sufficient to achieve a 2.4-nm lateral spacing between the two aircraft as they passed; however, the turn did not provide sufficient spacing to prevent a TCAS RA from being triggered in each aircraft. The climb by DLH411 and the descent by DLH420 provided vertical spacing of 1400 feet at the point of closest approach.
