PIPELINE INVESTIGATION REPORT

P00H0037

NATURAL GAS PIPELINE RUPTURE

WESTCOAST ENERGY INC.

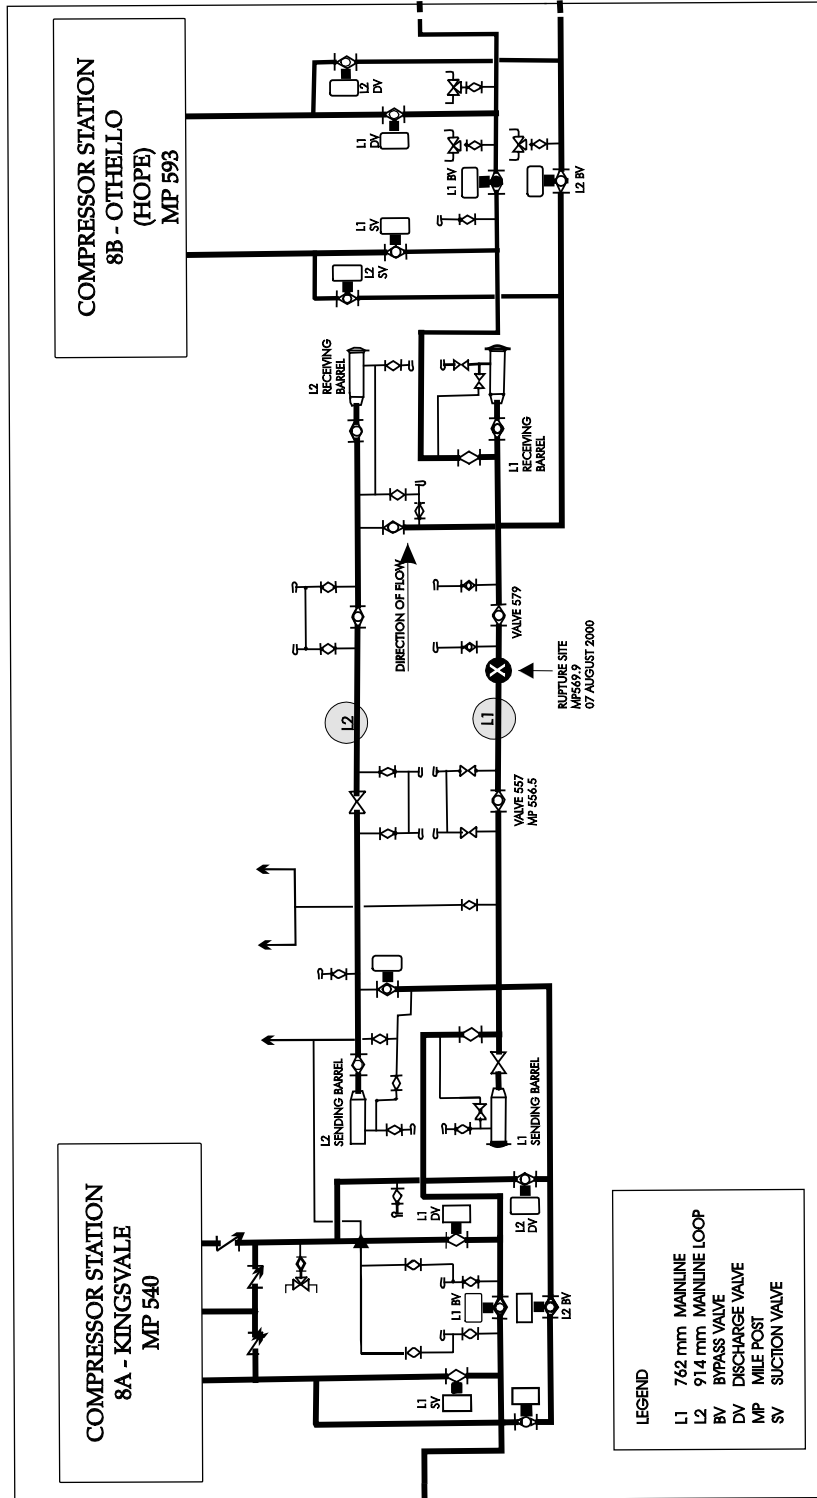
Appendix A - Schematic of T-South Mainline and Loop between Compressor Stations 8A and 8B

At 0408, the operator at Compressor Station 8A inadvertently opened the mainline discharge and bypass valves
